Area
GFL 122 Arrow Road - C13100
Machine Id
AG170
Component
Hydraulic System
Fluid
NOT GIVEN (--- GAL)

Customer Id: CHECOB
Sample No.: E30000194
Lab Number: 02576361
Test Package: IND 2

OIL ANALYSIS REPORT

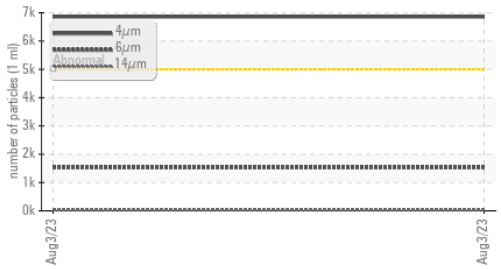
Particle Trend

Contamination
Particles >4µm are notably high. Particles >6µm and oil cleanliness are notably high.

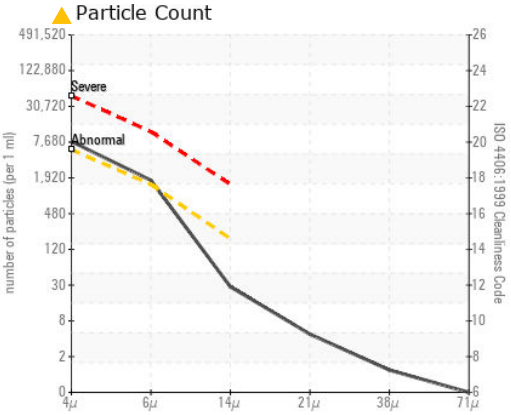
Particle Count

FLUID CLEANLINESS		method	limit/base	current	history1	history2
Particles >4µm		ASTM D7647	>5000	▲ **6855**	---	---
Particles >6µm		ASTM D7647	>1300	▲ **1529**	---	---
Particles >14µm		ASTM D7647	>160	**25**	---	---
Particles >21µm		ASTM D7647	>40	**4**	---	---
Particles >38µm		ASTM D7647	>10	**1**	---	---
Particles >71µm		ASTM D7647	>3	**0**	---	---
Oil Cleanliness		ISO 4406 (c)	>19/17/14	▲ **20/18/12**	---	---
