PROBLEM SUMMARY

OIL ANALYSIS REPORT

Area
Final Finishing Dept
Machine Id
FVM03
Component
Hydraulic System
Fluid
SHELL TELLUS S3 M 32 (50 GAL)

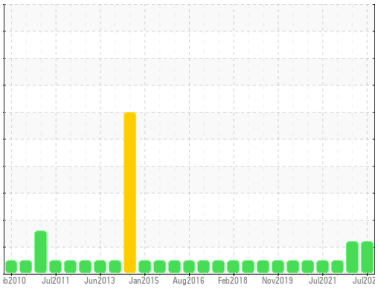
Sample Rating Trend

Sample Status				ABNORMAL	ABNORMAL	NORMAL
Particles >4µm		ASTM D7647	>5000	▲ **17237**	▲ 6645	629
Particles >6µm		ASTM D7647	>1300	▲ **2887**	1087	144
Oil Cleanliness		ISO 4406 (c)	>19/17/14	▲ **21/19/14**	▲ 20/17/12	16/14/11

We recommend you service the filters on this component. We recommend an early resample to monitor this condition.

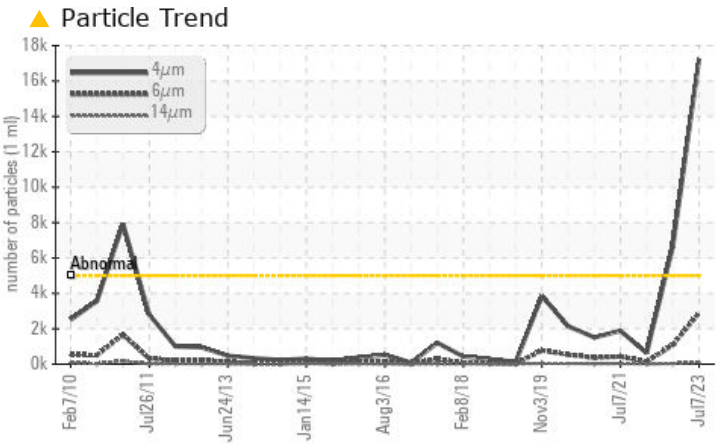
COMPONENT CONDITION SUMMARY

Wear
All component wear rates are normal.

Contamination
There is a moderate amount of silt (particulates < 14 microns in size) present in the oil.

Fluid Condition
The AN level is acceptable for this fluid. The oil is still serviceable provided that the contaminant(s) can be reduced to acceptable levels.

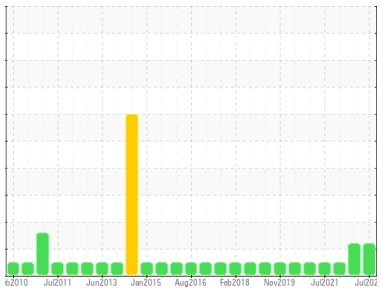
Sample Rating Trend

Recommendation
We recommend you service the filters on this component. We recommend an early resample to monitor this condition.

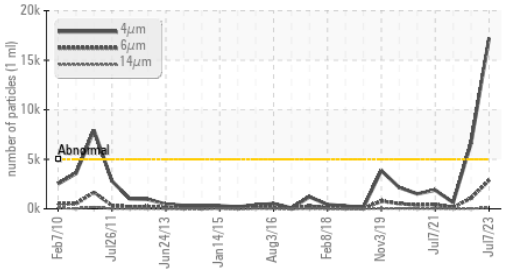
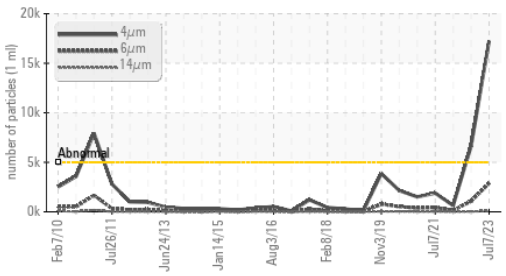
Particle Trend

FLUID CLEANLINESS		method	limit/base	current	history1	history2
Particles >4µm		ASTM D7647	>5000	▲ **17237**	▲ 6645	629
Particles >6µm		ASTM D7647	>1300	▲ **2887**	1087	144
Particles >14µm		ASTM D7647	>160	**82**	36	12
Particles >21µm		ASTM D7647	>40	**10**	12	3
Particles >38µm		ASTM D7647	>10	**1**	1	0
Particles >71µm		ASTM D7647	>3	**1**	0	0
Oil Cleanliness		ISO 4406 (c)	>19/17/14	▲ **21/19/14**	▲ 20/17/12	16/14/11

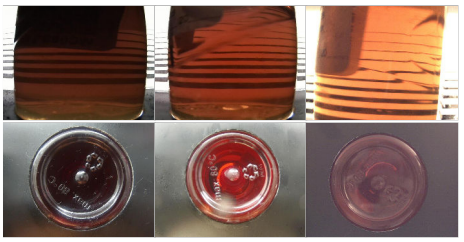
SAMPLE IMAGES	method	limit/base	current	history1	history2
Color					
Bottom

VISUAL		method	limit/base	current	history1	history2
White Metal	scalar	Visual*	NONE	**NONE**	NONE	NONE
Yellow Metal	scalar	Visual*	NONE	**NONE**	NONE	NONE
Precipitate	scalar	Visual*	NONE	**NONE**	NONE	NONE
Silt	scalar	Visual*	NONE	**VLITE**	NONE	NONE
Debris	scalar	Visual*	NONE	**NONE**	NONE	NONE
Sand/Dirt	scalar	Visual*	NONE	**NONE**	NONE	NONE
Appearance	scalar	Visual*	NORML	**NORML**	NORML	NORML
Odor	scalar	Visual*	NORML	**NORML**	NORML	NORML
Emulsified Water	scalar	Visual*	>0.05	**NEG**	NEG	NEG
Free Water	scalar	Visual*		**NEG**	NEG	NEG
