OIL ANALYSIS REPORT

Area
Ravenswood SP-24224
Machine Id
T1 (S/N 23945)
Component
Hydraulic System
Fluid
MOBIL AERO HF (280 LTR)

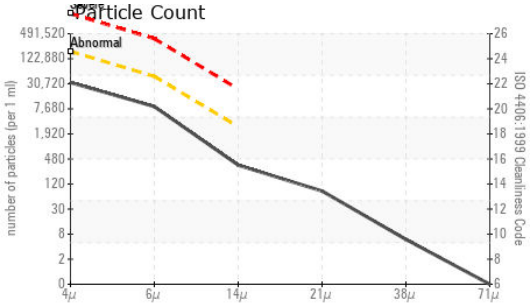
Particle Count

Contamination
The system cleanliness is acceptable for your target ISO 4406 cleanliness code. The water content is negligible. The system and fluid cleanliness is acceptable.

FLUID CLEANLINESS		method	limit/base	current	history1	history2
Particles >4µm		ASTM D7647	>160000	**28597**	426	348
Particles >6µm		ASTM D7647	>40000	**7602**	133	104
Particles >14µm		ASTM D7647	>2500	**300**	22	30
Particles >21µm		ASTM D7647	>640	**72**	9	15
Particles >38µm		ASTM D7647	>160	**5**	1	3
Particles >71µm		ASTM D7647	>40	**0**	0	0
Oil Cleanliness		ISO 4406 (c)	>24/22/18	**22/20/15**	16/14/12	16/14/12

Recommendation
Resample at the next service interval to monitor.
