PROBLEM SUMMARY

Area
Kingsbridge SP-13584
Machine Id
T21 (S/N 21750)
Component
Wind Turbine Gearbox
Fluid
CHEVRON PINNACLE WM 320 (--- LTR)

OIL ANALYSIS REPORT

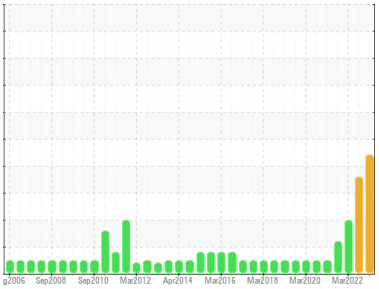
Sample Rating Trend

DEGRADATION

Sample Status				**SEVERE**	SEVERE	ABNORMAL
Iron	ppm	ASTM D5185(m)	>75	▲ **78**	74	▲ 76
Zinc	ppm	ASTM D5185(m)	0	▲ **25**	▲ 21	18
Acid Number (AN)	mg KOH/g	ASTM D974*	0.7	⬢ **1.53**	⬢ 1.54	▲ 1.47

Iron ppm levels are abnormal. The low ferrous density (PQ) index indicates the wear metal levels are due to corrosion.

Additive levels indicate the addition of a different brand, or type of oil. The high AN level of the oil indicates the presence of oxi-polymerized products. The AN level is much higher than the recommended limit. The oil is no longer serviceable.

We recommend that you drain the oil from the component if this has not already been done. Confirm the source of the lubricant being utilized for top-up/fill. We recommend an early resample to monitor this condition. NOTE: Please provide information regarding reservoir capacity, filter type and micron rating with next sample.

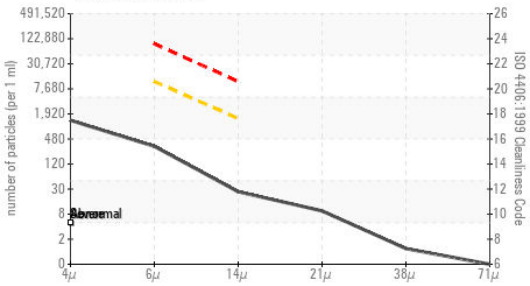
Particle Count

The system cleanliness is acceptable for your target ISO 4406 cleanliness code. The water content is negligible. The system and fluid cleanliness is acceptable.
