PROBLEM SUMMARY

Area
Ravenswood SP-24224
Machine Id
T5 (S/N 23963)
Component
Wind Turbine Gearbox
Fluid
MOBIL MOBILGEAR SHC XMP 320 (280 LTR)

OIL ANALYSIS REPORT

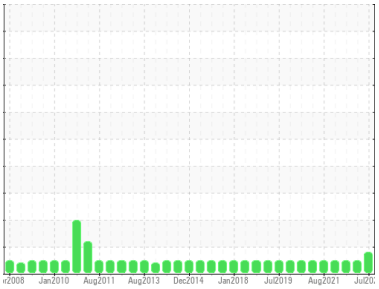
Sample Rating Trend

WEAR

▲ Non-ferrous Metals

Sample Status				**ABNORMAL**	NORMAL	NORMAL
Copper	ppm	ASTM D5185(m)	>5	▲ **6**	5	4

We recommend an early resample to monitor this condition.

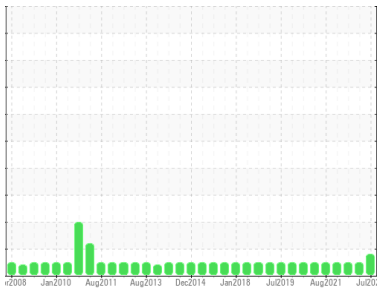
Sample Rating Trend

WEAR

Copper ppm levels are abnormal. Bearing and/or bushing wear is indicated.

We recommend an early resample to monitor this condition.
