Area
Ravenswood SP-24224
Machine Id
T4 (S/N 23960)
Component
Wind Turbine Gearbox
Fluid
MOBIL MOBILGEAR SHC XMP 320 (280 LTR)

Customer Id: VESTAS
Sample No.: WC0783104
Lab Number: 02576929
Test Package: IND 2

OIL ANALYSIS REPORT

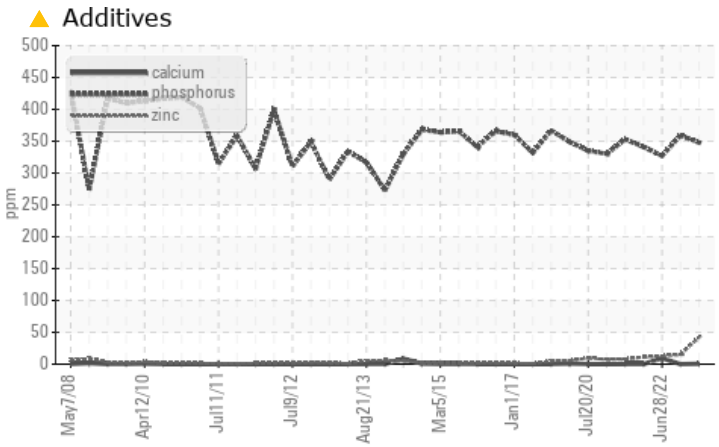
COMPONENT CONDITION SUMMARY

Sample Status				**ABNORMAL**	NORMAL	NORMAL
Zinc	ppm	ASTM D5185(m)	0	▲ **42**	15	13

Additive levels indicate the addition of a different brand, or type of oil. The AN level is acceptable for this fluid. The condition of the oil is suitable for further service.

Confirm the source of the lubricant being utilized for top-up/fill. Resample at the next service interval to monitor.
