OIL ANALYSIS REPORT

Area
Capital Power PDN - SC011776
Machine Id
T401 (S/N 00021HLKZA)
Component
Wind Turbine Gearbox
Fluid
MOBIL MOBILGEAR SHC XMP 320 (395 LTR)

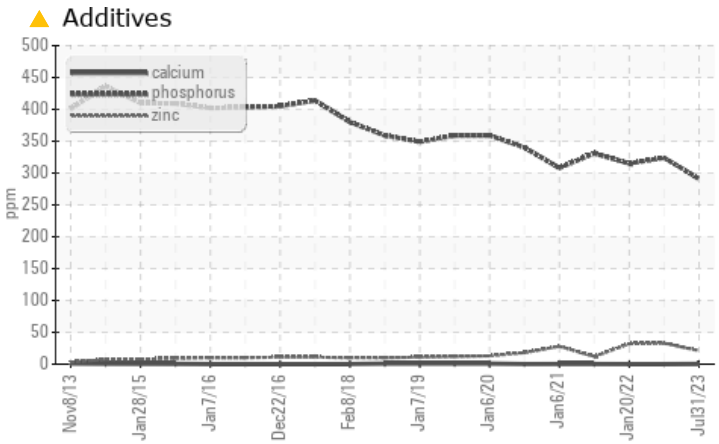
COMPONENT CONDITION SUMMARY

Sample Status				**ABNORMAL**	NORMAL	NORMAL
Phosphorus	ppm	ASTM D5185(m)	485	▲ **291**	324	315

Additive levels indicate the addition of a different brand, or type of oil. The AN level is acceptable for this fluid. The condition of the oil is suitable for further service.

Confirm the source of the lubricant being utilized for top-up/fill. Resample at the next service interval to monitor.

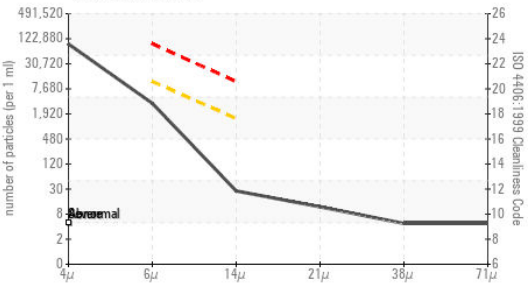
Particle Count

FLUID CLEANLINESS		method	limit/base	current	history1	history2
Particles >4µm		ASTM D7647		**79187**	1133	488
Particles >6µm		ASTM D7647	>10000	**3009**	166	54
Particles >14µm		ASTM D7647	>1300	**24**	11	2
Particles >21µm		ASTM D7647	>320	**10**	4	0
Particles >38µm		ASTM D7647	>80	**4**	0	0
Particles >71µm		ASTM D7647	>20	**4**	0	0
Oil Cleanliness		ISO 4406 (c)	>--/20/17	**23/19/12**	17/15/11	16/13/9

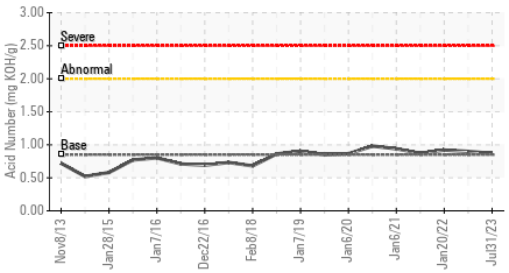
FLUID DEGRADATION		method	limit/base	current	history1	history2
Oxidation	Abs/.1mm	ASTM D7414*		**57.6**	24.3	57.6
Acid Number (AN)	mg KOH/g	ASTM D974*	0.85	**0.87**	0.90	0.92
