PROBLEM SUMMARY

Area
BRUCE B/5/43230
Machine Id
5-43230-P4-P IB Brg Drn
Component
Inboard Bearing
Fluid
ESSO NUTO H ISO 46 (--- GAL)

OIL ANALYSIS REPORT

FERROGRAPHY REPORT

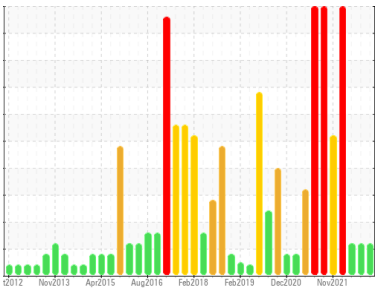
Sample Rating Trend

Sample Status				**ABNORMAL**	ABNORMAL	ABNORMAL
Particles >4µm		ASTM D7647	>5000	▲ **12008**	▲ 15293	▲ 38431
Particles >6µm		ASTM D7647	>1300	▲ **2305**	▲ 3018	▲ 7012
Oil Cleanliness		ISO 4406 (c)	>19/17/15	▲ **21/18/14**	▲ 21/19/15	▲ 22/20/15

We recommend you service the filters on this component. We recommend an early resample to monitor this condition. NOTE: Please provide information regarding reservoir capacity, filter type and micron rating with next sample.

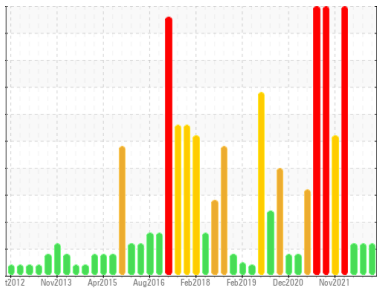
Sample Rating Trend

There is a moderate amount of silt (particulates < 14 microns in size) present in the oil. The water content is negligible. The system cleanliness is above the acceptable limit for the target ISO 4406 cleanliness code.

The AN level is acceptable for this fluid. The oil is still serviceable provided that the contaminant(s) can be reduced to acceptable levels.

We recommend you service the filters on this component. We recommend an early resample to monitor this condition. NOTE: Please provide information regarding reservoir capacity, filter type and micron rating with next sample.

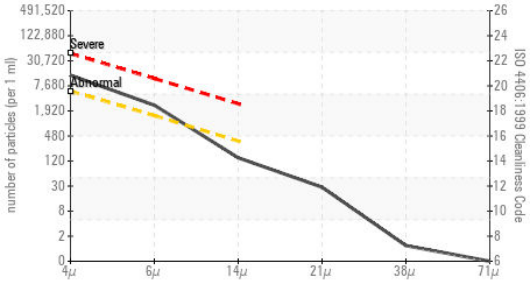
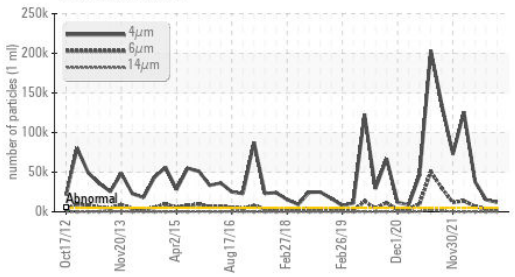
Particle Count

FLUID CLEANLINESS		method	limit/base	current	history1	history2
Particles >4µm		ASTM D7647	>5000	▲ **12008**	▲ 15293	▲ 38431
Particles >6µm		ASTM D7647	>1300	▲ **2305**	▲ 3018	▲ 7012
Particles >14µm		ASTM D7647	>320	**127**	163	203
Particles >21µm		ASTM D7647	>80	**25**	36	26
Particles >38µm		ASTM D7647	>20	**1**	4	1
Particles >71µm		ASTM D7647	>4	**0**	0	0
Oil Cleanliness		ISO 4406 (c)	>19/17/15	▲ **21/18/14**	▲ 21/19/15	▲ 22/20/15

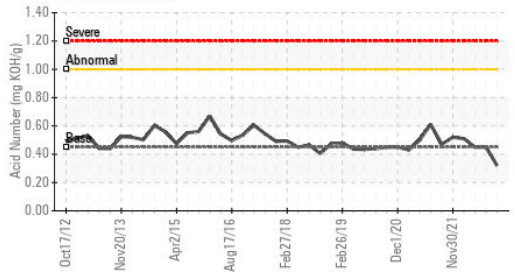
FLUID DEGRADATION		method	limit/base	current	history1	history2
Acid Number (AN)	mg KOH/g	ASTM D974*	0.45	**0.32**	0.45	0.45

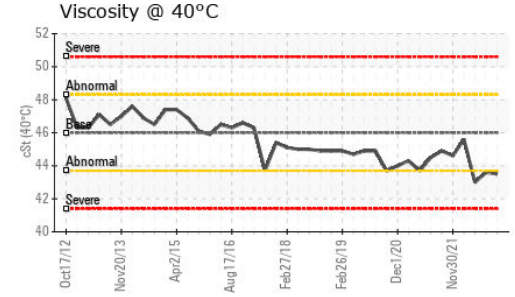
Viscosity @ 40°C

FLUID PROPERTIES		method	limit/base	current	history1	history2
Visc @ 40°C	cSt	ASTM D7279(m)	46	**43.5**	43.6	43.0

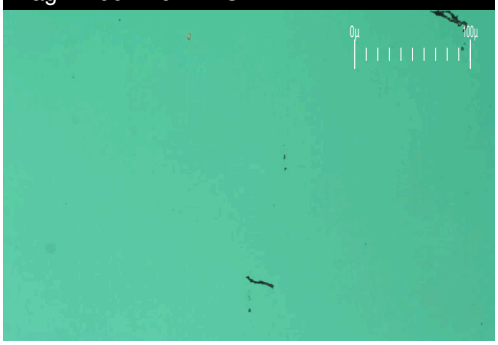
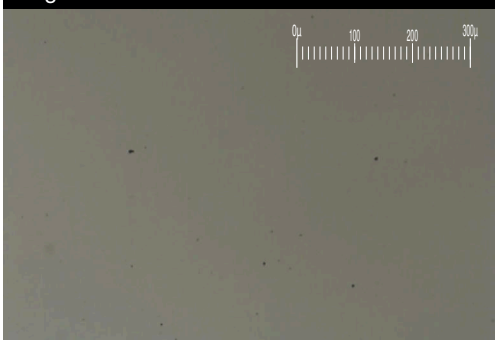
Magn: 200x Illum: BC

All component wear rates are normal. The direct-reading & analytical ferrographic results are normal indicating no abnormal wear in the system.
