Customer Id: ARDMIS
Sample No.: WC0651228
Lab Number: 02577274
Test Package: IND 2

OIL ANALYSIS REPORT

Area
[CA-01-200091081]
Machine Id
CA-1023800 (S/N 95503422)
Component
Blower
Fluid
MOBIL SHC 630 (--- GAL)

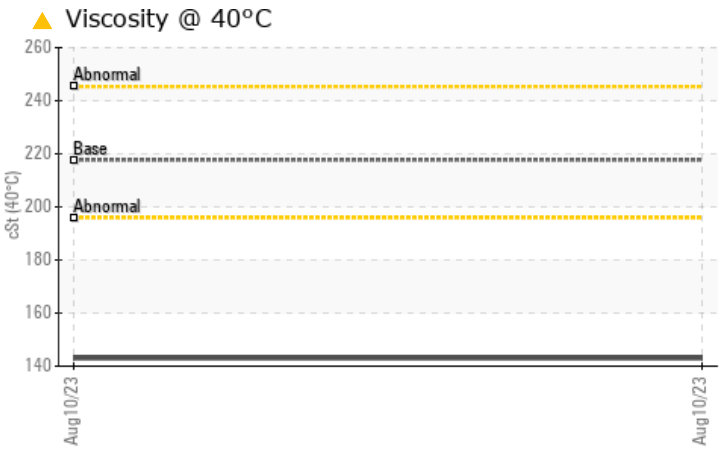
Sample Rating Trend

Fluid Condition
Viscosity of sample indicates oil is within ISO 150 range, advise investigate. This plus the additive levels indicates that this is not the same brand, or type of oil as reported. The AN level is acceptable for this fluid. The condition of the oil is suitable for further service.

Confirm the source of the lubricant being utilized for top-up/fill. Resample at the next service interval to monitor. NOTE: Please provide information regarding reservoir capacity, filter type and micron rating with next sample.

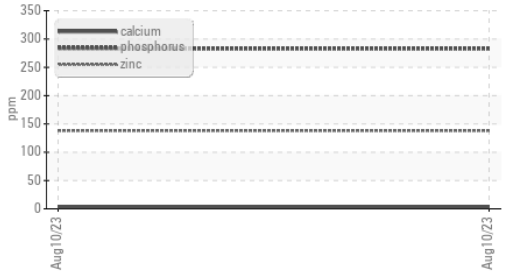
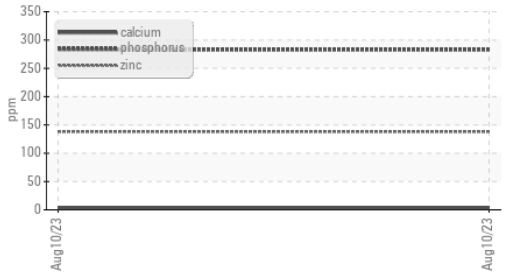
Additives

ADDITIVES		method	limit/base	current	history1	history2
Boron	ppm	ASTM D5185(m)		**2**	---	---
Barium	ppm	ASTM D5185(m)		**0**	---	---
Molybdenum	ppm	ASTM D5185(m)		**0**	---	---
Manganese	ppm	ASTM D5185(m)		**2**	---	---
Magnesium	ppm	ASTM D5185(m)		**3**	---	---
Calcium	ppm	ASTM D5185(m)		**3**	---	---
Phosphorus	ppm	ASTM D5185(m)		**283**	---	---
Zinc	ppm	ASTM D5185(m)		▲ **138**	---	---
Sulfur	ppm	ASTM D5185(m)		▲ **5718**	---	---
Lithium	ppm	ASTM D5185(m)		**1**	---	---

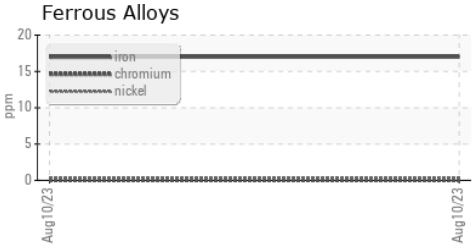
Ferrous Alloys

Wear
All component wear rates are normal.

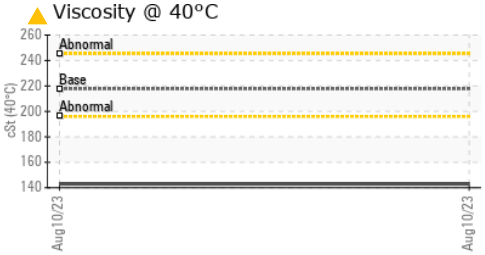
Viscosity @ 40°C

FLUID PROPERTIES		method	limit/base	current	history1	history2
Visc @ 40°C	cSt	ASTM D7279(m)	217.7	▲ **143**	---	---
