Area
Baytech - W00300 [PRESS 31]
Machine Id
A2308090
Component
Hydraulic System
Fluid
AW HYDRAULIC OIL ISO 46 (--- GAL)

Customer Id: CHECOB
Sample No.: E30000118
Lab Number: 02577476
Test Package: IND 2

OIL ANALYSIS REPORT

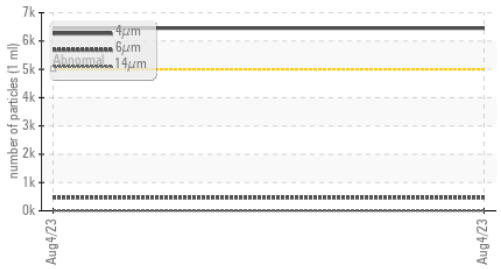
Particle Trend

Contamination
Particles >4µm and oil cleanliness are notably high.

FLUID CLEANLINESS		method	limit/base	current	history1	history2
Particles >4µm		ASTM D7647	>5000	▲ **6453**	---	---
Particles >6µm		ASTM D7647	>1300	**466**	---	---
Particles >14µm		ASTM D7647	>160	**9**	---	---
Particles >21µm		ASTM D7647	>40	**3**	---	---
Particles >38µm		ASTM D7647	>10	**1**	---	---
Particles >71µm		ASTM D7647	>3	**0**	---	---
Oil Cleanliness		ISO 4406 (c)	>19/17/14	▲ **20/16/10**	---	---
