PROBLEM SUMMARY

Machine Id
OKUMA 2 CNC HPU
Component
Hydraulic System
Fluid
MOBIL DTE EXCEL ISO 32 (40 LTR)

OIL ANALYSIS REPORT

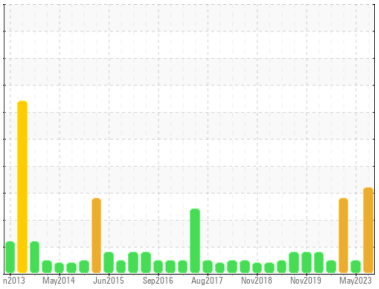
Sample Rating Trend

Sample Status				SEVERE	NORMAL	ABNORMAL
Particles >4µm		ASTM D7647	>5000	**43514**	4577	18640
Particles >6µm		ASTM D7647	>1300	**9858**	1036	2488
Particles >14µm		ASTM D7647	>160	**426**	46	125
Particles >21µm		ASTM D7647	>40	**202**	11	49
Particles >38µm		ASTM D7647	>10	**49**	1	5
Oil Cleanliness		ISO 4406 (c)	>19/17/14	**23/20/16**	19/17/13	21/18/14

We advise that you check all areas where contaminants can enter the system. We advise that you perform a filter service, and use off-line filtration to improve the cleanliness of the system fluid. The air breather requires service. If unrated, we recommend that you replace with a suitable micron rated and/or desiccant air breather. If rated, we recommend that you service/replace the breather. Resample in 30-45 days to monitor this situation.

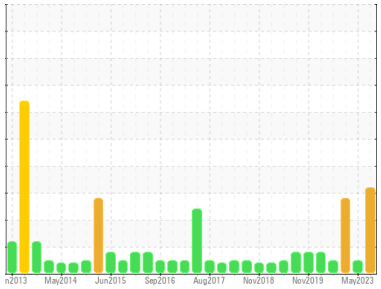
Sample Rating Trend

There is a high amount of particulates (2 to 100 microns in size) present in the oil.

The AN level is acceptable for this fluid. The oil is still serviceable provided that the contaminant(s) can be reduced to acceptable levels.

FLUID CLEANLINESS		method	limit/base	current	history1	history2
Particles >4µm		ASTM D7647	>5000	● **43514**	4577	▲ 18640
Particles >6µm		ASTM D7647	>1300	▲ **9858**	1036	▲ 2488
Particles >14µm		ASTM D7647	>160	▲ **426**	46	125
Particles >21µm		ASTM D7647	>40	▲ **202**	11	49
Particles >38µm		ASTM D7647	>10	▲ **49**	1	5
Particles >71µm		ASTM D7647	>3	**4**	0	1
Oil Cleanliness		ISO 4406 (c)	>19/17/14	● **23/20/16**	19/17/13	▲ 21/18/14

We advise that you check all areas where contaminants can enter the system. We advise that you perform a filter service, and use off-line filtration to improve the cleanliness of the system fluid. The air breather requires service. If unrated, we recommend that you replace with a suitable micron rated and/or desiccant air breather. If rated, we recommend that you service/replace the breather. Resample in 30-45 days to monitor this situation.

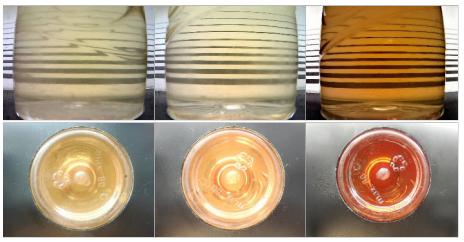
SAMPLE IMAGES	method	limit/base	current	history1	history2
Color					
Bottom

VISUAL		method	limit/base	current	history1	history2
White Metal	scalar	Visual*	NONE	**NONE**	NONE	NONE
Yellow Metal	scalar	Visual*	NONE	**NONE**	NONE	NONE
Precipitate	scalar	Visual*	NONE	**NONE**	NONE	NONE
Silt	scalar	Visual*	NONE	**NONE**	NONE	NONE
Debris	scalar	Visual*	NONE	**VLITE**	NONE	NONE
Sand/Dirt	scalar	Visual*	NONE	**NONE**	NONE	NONE
Appearance	scalar	Visual*	NORML	**NORML**	NORML	NORML
Odor	scalar	Visual*	NORML	**NORML**	NORML	NORML
Emulsified Water	scalar	Visual*	>0.05	**NEG**	NEG	NEG
Free Water	scalar	Visual*		**NEG**	NEG	NEG
