Customer Id: EXXSTJ
Sample No.: PP13907152
Lab Number: 02577523
Test Package: MAR 2

OIL ANALYSIS REPORT

Area
Gas Compression
Machine Id
V650201 GTC 1
Component
Jet Turbine
Fluid
MOBIL JET OIL II (--- GAL)

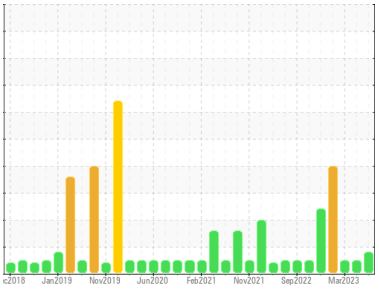
Sample Rating Trend

Sample Status				ATTENTION	NORMAL	NORMAL
Particles >4µm		ASTM D7647	>2500	▲ 3351	887	2216
Oil Cleanliness		ISO 4406 (c)	>18/16/13	▲ 19/16/12	17/15/12	18/16/11

We recommend you service the filters on this component. Resample at the next service interval to monitor. NOTE: Please provide information regarding reservoir capacity, filter type and micron rating with next sample.

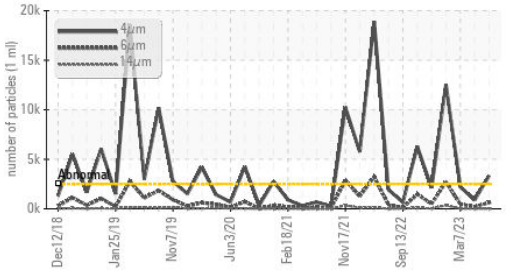
Particle Trend

Contamination
There is a light amount of silt (particulates < 14 microns in size) present in the oil.

FLUID CLEANLINESS		method	limit/base	current	history1	history2
Particles >4µm		ASTM D7647	>2500	▲ **3351**	887	2216
Particles >6µm		ASTM D7647	>640	**624**	225	468
Particles >14µm		ASTM D7647	>80	**23**	23	15
Particles >21µm		ASTM D7647	>20	**6**	9	4
Particles >38µm		ASTM D7647	>4	**2**	1	1
Particles >71µm		ASTM D7647	>3	**0**	0	0
Oil Cleanliness		ISO 4406 (c)	>18/16/13	▲ **19/16/12**	17/15/12	18/16/11

Recommendation
We recommend you service the filters on this component. Resample at the next service interval to monitor. NOTE: Please provide information regarding reservoir capacity, filter type and micron rating with next sample.
