PROBLEM SUMMARY

Area
Gas Compression
Machine Id
V650221 GTC 2
Component
Turbine
Fluid
MOBIL JET OIL II (--- LTR)

Customer Id: EXXSTJ
Sample No.: PP13907152
Lab Number: 02577524
Test Package: MAR 2

OIL ANALYSIS REPORT

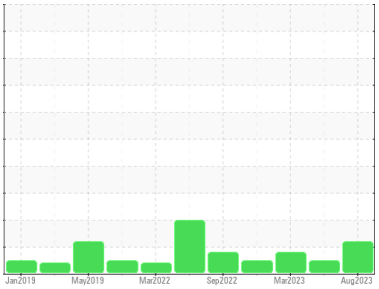
Sample Rating Trend

Sample Status				ATTENTION	NORMAL	ATTENTION
Particles >4µm		ASTM D7647	>2500	▲ **3384**	755	▲ 2606
Particles >6µm		ASTM D7647	>640	▲ **921**	169	454
Oil Cleanliness		ISO 4406 (c)	>18/16/13	▲ **19/17/13**	17/15/11	▲ 19/16/11

Contamination
There is a light amount of silt (particulates < 14 microns in size) present in the oil.

We recommend you service the filters on this component. Resample at the next service interval to monitor. NOTE: Please provide information regarding reservoir capacity, filter type and micron rating with next sample.
