Area
System 56 - Hazardous Drains [13884889]
Machine Id
Z-5601A Centrifuge Gearbox Lube Oil
Component
Gearbox
Fluid
GEAR OIL ISO 320 (13 LTR)

OIL ANALYSIS REPORT

Laboratory : WearCheck - C8-1175 Appleby Line, Burlington, ON L7L 5H9
Sample No. : PP
Lab Number : 02577585
Unique Number : 5630645
Test Package : MAR 2 (Additional Tests: KF, PrtCount)

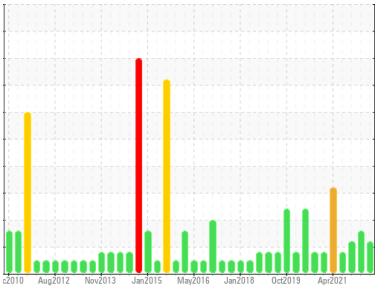
Sample Rating Trend

Sample Status				ABNORMAL	ABNORMAL	ABNORMAL
Particles >4µm		ASTM D7647	>20000	▲ **138831**	▲ 62449	▲ 42770
Particles >6µm		ASTM D7647	>5000	▲ **18584**	▲ 9425	4042
Oil Cleanliness		ISO 4406 (c)	>21/19/16	▲ **24/21/15**	▲ 23/20/15	▲ 23/19/14

We recommend you service the filters on this component. We recommend an early resample to monitor this condition. Please specify the brand, type, and viscosity of the oil on your next sample.

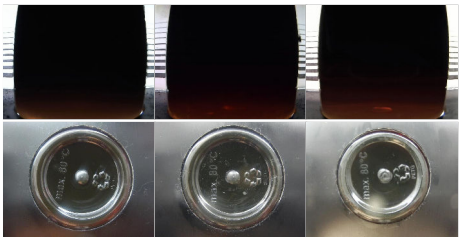
SAMPLE IMAGES	method	limit/base	current	history1	history2
Color					
Bottom

VISUAL		method	limit/base	current	history1	history2
White Metal	scalar	Visual*	NONE	**NONE**	NONE	NONE
Yellow Metal	scalar	Visual*	NONE	**NONE**	NONE	NONE
Precipitate	scalar	Visual*	NONE	**NONE**	NONE	NONE
Silt	scalar	Visual*	NONE	**NONE**	NONE	NONE
Debris	scalar	Visual*	NONE	**VLITE**	NONE	VLITE
Sand/Dirt	scalar	Visual*	NONE	**NONE**	NONE	NONE
Appearance	scalar	Visual*	NORML	**NORML**	NORML	NORML
Odor	scalar	Visual*	NORML	**NORML**	NORML	NORML
Emulsified Water	scalar	Visual*	>0.2	**NEG**	NEG	NEG
Free Water	scalar	Visual*		**NEG**	NEG	NEG

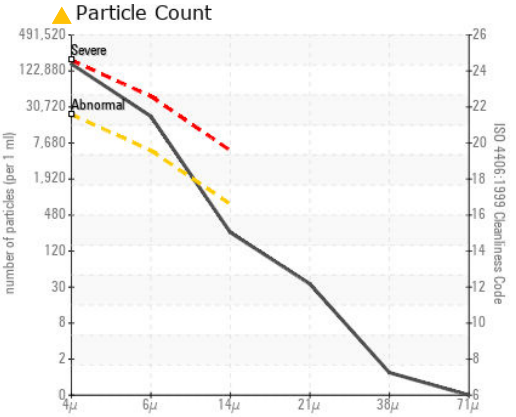
Particle Count

There is a moderate amount of silt (particulates < 14 microns in size) present in the oil. The water content is negligible.

FLUID CLEANLINESS		method	limit/base	current	history1	history2
Particles >4µm		ASTM D7647	>20000	▲ **138831**	▲ 62449	▲ 42770
Particles >6µm		ASTM D7647	>5000	▲ **18584**	▲ 9425	4042
Particles >14µm		ASTM D7647	>640	**216**	268	92
Particles >21µm		ASTM D7647	>160	**30**	38	18
Particles >38µm		ASTM D7647	>40	**1**	0	1
Particles >71µm		ASTM D7647	>10	**0**	0	1
Oil Cleanliness		ISO 4406 (c)	>21/19/16	▲ **24/21/15**	▲ 23/20/15	▲ 23/19/14

We recommend you service the filters on this component. We recommend an early resample to monitor this condition. Please specify the brand, type, and viscosity of the oil on your next sample.
