PROBLEM SUMMARY

Area
Direct Strip Mill/Finishing
Machine Id
PH3 HYDRAULIC SYSTEM (DSC004) (S/N 1000014662)
Component
Hydraulic System
Fluid
HOUGHTON HOUGHTO-SAFE 620 (15000 LTR)

OIL ANALYSIS REPORT

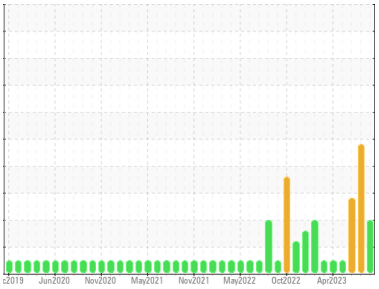
Sample Rating Trend

ISO

Sample Status				ABNORMAL	SEVERE	ABNORMAL
Particles >4µm		ASTM D7647	>640	**735**	5797	424
Particles >6µm		ASTM D7647	>160	**379**	1619	205
Particles >14µm		ASTM D7647	>20	**85**	71	54
Particles >21µm		ASTM D7647	>4	**35**	21	27
Oil Cleanliness		ISO 4406 (c)	>16/14/11	**17/16/14**	20/18/13	16/15/13

We advise that you perform a filter service, and use off-line filtration to improve the cleanliness of the system fluid. We recommend an early resample to monitor this condition.

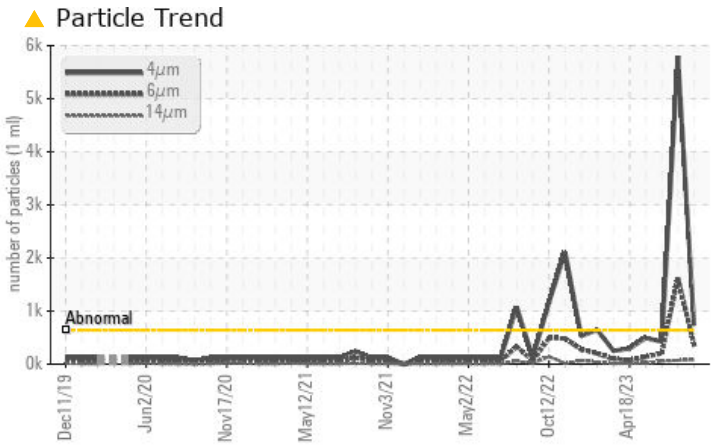
COMPONENT CONDITION SUMMARY

There is a moderate amount of particulates (2 to 100 microns in size) present in the oil. The system cleanliness is above the acceptable limit for the target ISO 4406 cleanliness code.

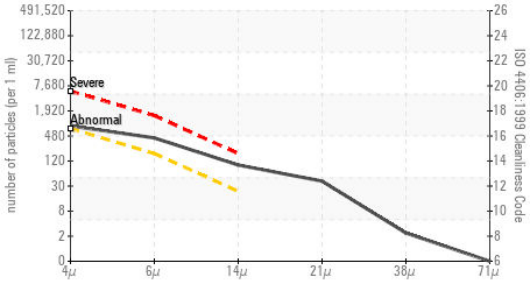
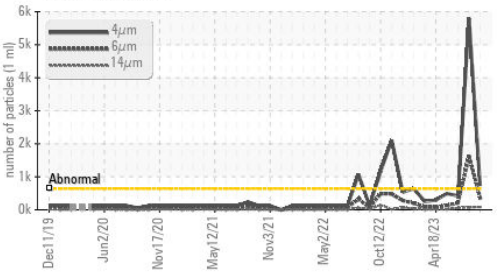
Particle Count

FLUID CLEANLINESS		method	limit/base	current	history1	history2
Particles >4µm		ASTM D7647	>640	▲ **735**	⬢ 5797	424
Particles >6µm		ASTM D7647	>160	▲ **379**	⬢ 1619	▲ 205
Particles >14µm		ASTM D7647	>20	▲ **85**	▲ 71	▲ 54
Particles >21µm		ASTM D7647	>4	▲ **35**	▲ 21	▲ 27
Particles >38µm		ASTM D7647	>3	**2**	▲ 6	4
Particles >71µm		ASTM D7647	>3	**0**	0	0
Oil Cleanliness		ISO 4406 (c)	>16/14/11	▲ **17/16/14**	⬢ 20/18/13	▲ 16/15/13

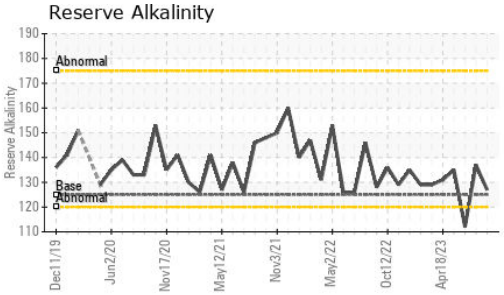
Reserve Alkalinity

FLUID DEGRADATION		method	limit/base	current	history1	history2
Acid Number (AN)	mg KOH/g	ASTM D974*		**4.83**	4.28	4.84
Alkiline Reserve (Oils)	ml KOH/g	ASTM D1121*	125	**127**	137	▲ 112

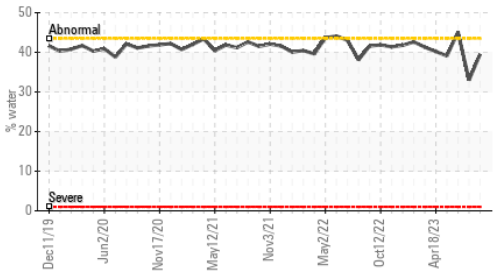
CONTAMINANTS		method	limit/base	current	history1	history2
Silicon	ppm	ASTM D5185(m)	>20	**0**	<1	0
Sodium	ppm	ASTM D5185(m)		**<1**	14	18
Potassium	ppm	ASTM D5185(m)	>20	**<1**	19	0
Water	%	ASTM D6304*	>43.5	**39.51**	33.0	45.1
ppm Water	ppm	ASTM D6304*	>435000	**395178.3**	330000	451000
