Machine Id
LOWER STURGEON WD LOG LIFTER
Component
Unknown Component
Fluid
ESSO UNIVIS EXTRA (--- GAL)

Customer Id: ONT801TIM
Sample No.: WC0618983
Lab Number: 02578478
Test Package: IND 2

OIL ANALYSIS REPORT

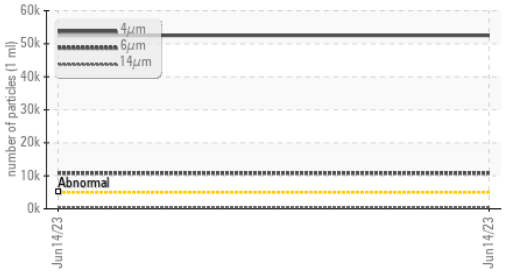
Particle Trend

Sample Status				**SEVERE**	---	---
Particles >4µm		ASTM D7647	>5000	**52507**	---	---
Particles >6µm		ASTM D7647	>1300	**10793**	---	---
Particles >14µm		ASTM D7647	>160	**414**	---	---
Particles >21µm		ASTM D7647	>40	**61**	---	---
Oil Cleanliness		ISO 4406 (c)	>19/17/14	**23/21/16**	---	---

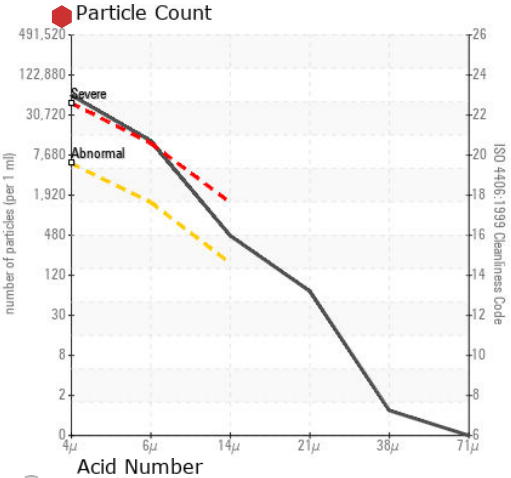
Particle Count

There is a high amount of silt (particulates < 14 microns in size) present in the sample.

FLUID CLEANLINESS		method	limit/base	current	history1	history2
Particles >4µm		ASTM D7647	>5000	**52507**	---	---
Particles >6µm		ASTM D7647	>1300	**10793**	---	---
Particles >14µm		ASTM D7647	>160	**414**	---	---
Particles >21µm		ASTM D7647	>40	**61**	---	---
Particles >38µm		ASTM D7647	>10	**1**	---	---
Particles >71µm		ASTM D7647	>3	**0**	---	---
Oil Cleanliness		ISO 4406 (c)	>19/17/14	**23/21/16**	---	---

Check seals and/or filters for points of contaminant entry. The air breather requires service. If unrated, we recommend that you replace with a suitable micron rated and/or desiccant air breather. If rated, we recommend that you service/replace the breather. We recommend you service the filters on this component. Resample in 30-45 days to monitor this situation. NOTE: Please provide information regarding reservoir capacity, filter type and micron rating with next sample.
