PROBLEM SUMMARY

Area
SAB1
Machine Id
SAB1 G4
Component
Turbine Bearing
Fluid
ESSO TERESSO ISO 46 (150 LTR)

Customer Id: ONTQUE
Sample No.: WC0828616
Lab Number: 02578784
Test Package: IND 2

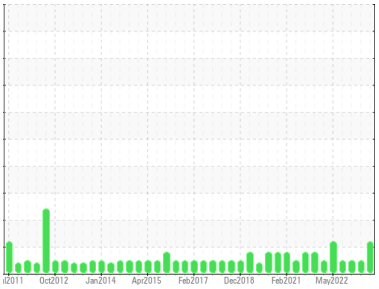
Sample Rating Trend

Sample Status				ABNORMAL	NORMAL	NORMAL
Particles >4µm		ASTM D7647	>10000	▲ **42139**	1659	1568
Particles >6µm		ASTM D7647	>1300	▲ **4254**	543	236
Oil Cleanliness		ISO 4406 (c)	>20/17/14	▲ **23/19/12**	18/16/12	18/15/12

We recommend you service the filters on this component. We recommend an early resample to monitor this condition.

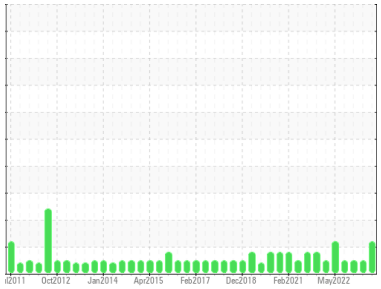
Sample Rating Trend

There is a moderate amount of silt (particulates < 14 microns in size) present in the oil. The system cleanliness is above the acceptable limit for the target ISO 4406 cleanliness code.

FLUID CLEANLINESS		method	limit/base	current	history1	history2
Particles >4µm		ASTM D7647	>10000	▲ **42139**	1659	1568
Particles >6µm		ASTM D7647	>1300	▲ **4254**	543	236
Particles >14µm		ASTM D7647	>160	**24**	39	27
Particles >21µm		ASTM D7647	>40	**3**	9	8
Particles >38µm		ASTM D7647	>10	**1**	0	0
Particles >71µm		ASTM D7647	>3	**0**	0	0
Oil Cleanliness		ISO 4406 (c)	>20/17/14	▲ **23/19/12**	18/16/12	18/15/12

We recommend you service the filters on this component. We recommend an early resample to monitor this condition.
