OIL ANALYSIS REPORT

Machine Id
TIMM #2 PLUNGER 2
Component
Gearbox
Fluid
SHELL OMALA S2 G 68 (--- GAL)

FERROGRAPHY REPORT

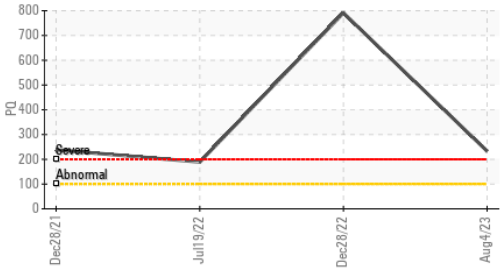
PQ levels are abnormal. Iron ppm levels are abnormal. Gear wear is indicated. The high ferrous density (PQ) index indicates that abnormal wear is occurring. The direct-reading & analytical ferrographic results are normal indicating no abnormal wear in the system.

The oil change at the time of sampling has been noted. We recommend an early resample to monitor this condition. NOTE: Please provide information regarding reservoir capacity, filter type and micron rating with next sample.

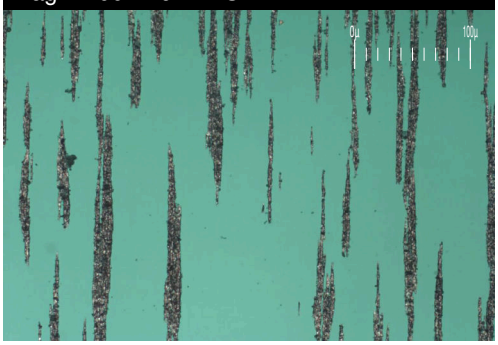
Magn: 200x Illum: BC

PQ levels are abnormal. Iron ppm levels are abnormal. Gear wear is indicated. The high ferrous density (PQ) index indicates that abnormal wear is occurring. The direct-reading & analytical ferrographic results are normal indicating no abnormal wear in the system.
