Customer Id: TOYCAM
Sample No.: CB0031441
Lab Number: 02579127
Test Package: IND 3

OIL ANALYSIS REPORT

Machine Id
TIMM #2 PLUNGER 5
Component
Gearbox
Fluid
SHELL OMALA S2 G 68 (--- GAL)

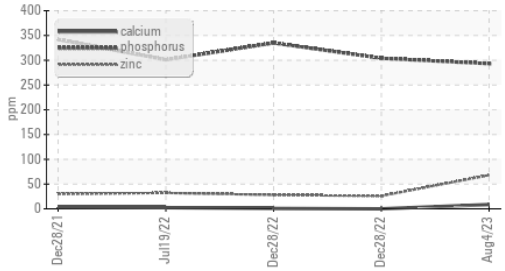
Additives

Additive levels indicate the addition of a different brand, or type of oil. The AN level is acceptable for this fluid. The condition of the oil is suitable for further service.

Confirm the source of the lubricant being utilized for top-up/fill. Resample at the next service interval to monitor. NOTE: Please provide information regarding reservoir capacity, filter type and micron rating with next sample.

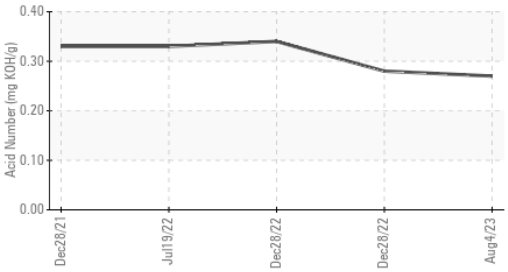
FLUID DEGRADATION		method	limit/base	current	history1	history2
Acid Number (AN)	mg KOH/g	ASTM D974*		**0.27**	0.28	0.34

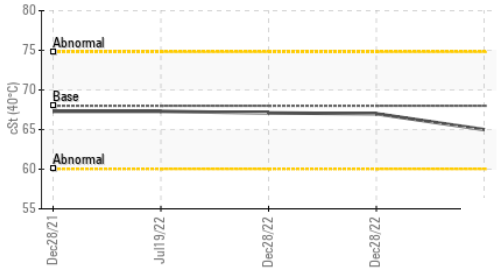
Viscosity @ 40°C

FLUID PROPERTIES		method	limit/base	current	history1	history2
Visc @ 40°C	cSt	ASTM D7279(m)	68.0	**65.0**	67.0	67.1

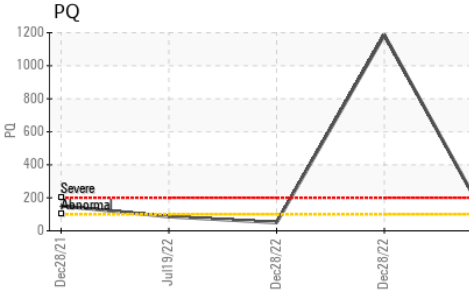
PQ

All component wear rates are normal. The direct-reading & analytical ferrographic results are normal indicating no abnormal wear in the system.

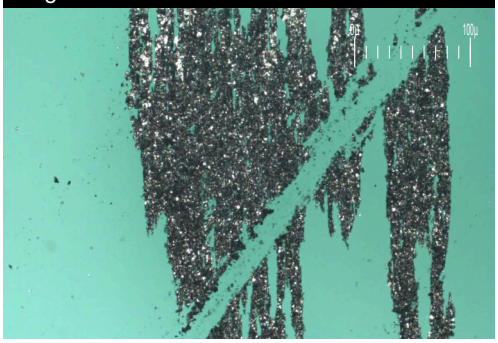
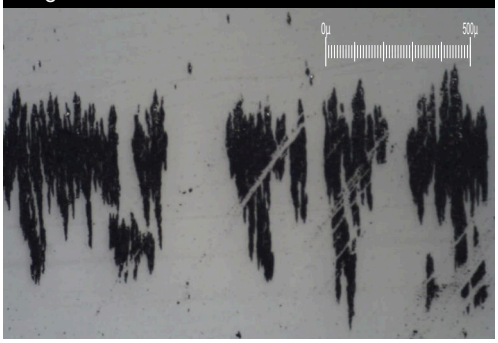
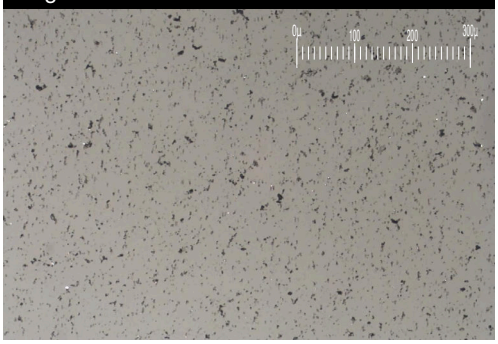
FERROGRAPHY REPORT

All component wear rates are normal. The direct-reading & analytical ferrographic results are normal indicating no abnormal wear in the system.
