Customer Id: SAL364SAL
Sample No.: WC0815330
Lab Number: 02579129
Test Package: IND 2

OIL ANALYSIS REPORT

Machine Id
SALFORD #11
Component
Hydraulic System
Fluid
CHEVRON 1000 THF (--- GAL)

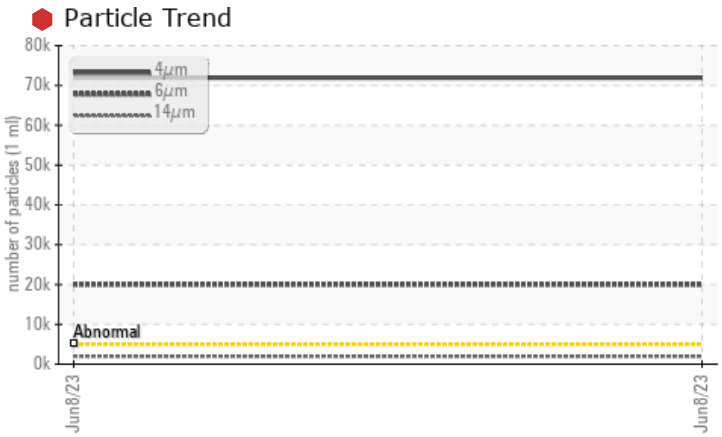
COMPONENT CONDITION SUMMARY

Sample Status				**SEVERE**	---	---
Particles >4µm		ASTM D7647	>5000	**71921**	---	---
Particles >6µm		ASTM D7647	>1300	**20014**	---	---
Particles >14µm		ASTM D7647	>160	**1958**	---	---
Particles >21µm		ASTM D7647	>40	**770**	---	---
Particles >38µm		ASTM D7647	>10	**74**	---	---
Particles >71µm		ASTM D7647	>3	**8**	---	---
Oil Cleanliness		ISO 4406 (c)	>19/17/14	**23/22/18**	---	---
Debris	scalar	Visual*	NONE	**LTMOD**	---	---
PrtFilter

We advise that you check all areas where contaminants can enter the system. We advise that you perform a filter service, and use off-line filtration to improve the cleanliness of the system fluid. The air breather requires service. If unrated, we recommend that you replace with a suitable micron rated and/or desiccant air breather. If rated, we recommend that you service/replace the breather. Resample in 30-45 days to monitor this situation. NOTE: Please provide information regarding reservoir capacity, filter type and micron rating with next sample. Please specify the component make and model with your next sample. We suspect that the abnormal contaminant(s) is the result of incorrect sampling technique. DISCLAIMER: Interpretation of results is based on the sample as received from the customer. The condition of the sample and the method of sampling cannot be verified.

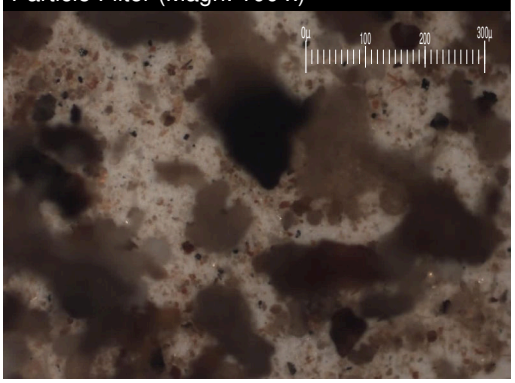
Particle Filter (Magn: 100 x)

There is a high amount of particulates (2 to 100 microns in size) present in the oil. Moderate concentration of visible dirt/debris present in the oil.

We advise that you check all areas where contaminants can enter the system. We advise that you perform a filter service, and use off-line filtration to improve the cleanliness of the system fluid. The air breather requires service. If unrated, we recommend that you replace with a suitable micron rated and/or desiccant air breather. If rated, we recommend that you service/replace the breather. Resample in 30-45 days to monitor this situation. NOTE: Please provide information regarding reservoir capacity, filter type and micron rating with next sample. Please specify the component make and model with your next sample. We suspect that the abnormal contaminant(s) is the result of incorrect sampling technique. DISCLAIMER: Interpretation of results is based on the sample as received from the customer. The condition of the sample and the method of sampling cannot be verified.

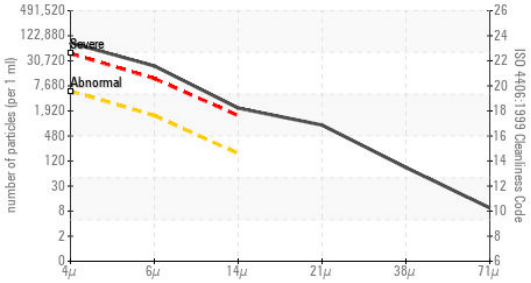
Particle Count

FLUID CLEANLINESS		method	limit/base	current	history1	history2
Particles >4µm		ASTM D7647	>5000	**71921**	---	---
Particles >6µm		ASTM D7647	>1300	**20014**	---	---
Particles >14µm		ASTM D7647	>160	**1958**	---	---
Particles >21µm		ASTM D7647	>40	**770**	---	---
Particles >38µm		ASTM D7647	>10	**74**	---	---
Particles >71µm		ASTM D7647	>3	**8**	---	---
Oil Cleanliness		ISO 4406 (c)	>19/17/14	**23/22/18**	---	---
