Customer Id: TOYCAM
Sample No.: CB0031436
Lab Number: 02579211
Test Package: IND 3

OIL ANALYSIS REPORT

Machine Id
TIMM 2 B BARREL
Component
Gearbox
Fluid
SHELL OMALA 68 (--- GAL)

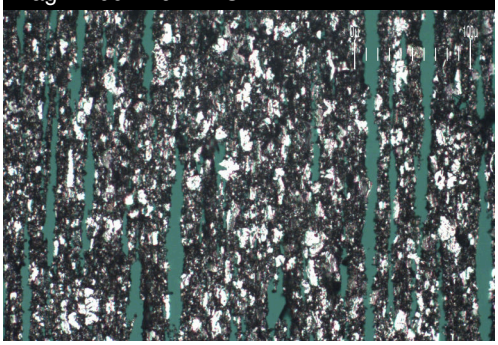
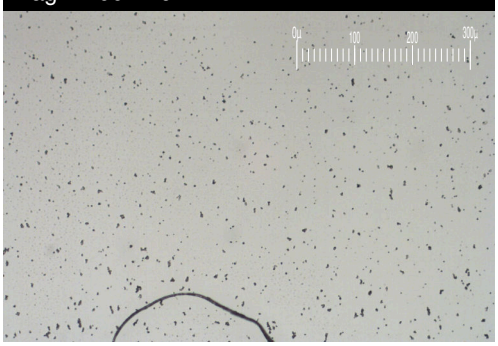
Wear particle analysis indicates that the ferrous rubbing particles are abnormal. Wear particle analysis indicates that the ferrous rolling particles are marginal.

The oil change at the time of sampling has been noted. We recommend an early resample to monitor this condition. No other corrective action is recommended at this time. NOTE: Please provide information regarding reservoir capacity, filter type and micron rating with next sample.
