Customer Id: CARGUE
Sample No.: WC0828644
Lab Number: 02579676
Test Package: IND 2

OIL ANALYSIS REPORT

Area
[412256495]
Machine Id
1000029345
Component
Hydraulic System
Fluid
TOTAL FINA NEVASTANE FG AW 46 (--- GAL)

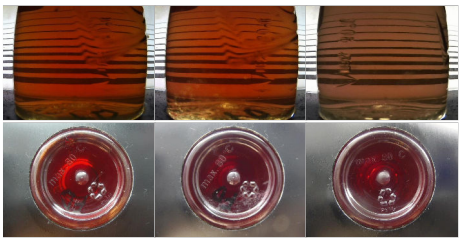
SAMPLE IMAGES	method	limit/base	current	history1	history2
Color					
Bottom

There is a moderate amount of particulates (2 to 100 microns in size) present in the oil.

VISUAL		method	limit/base	current	history1	history2
White Metal	scalar	Visual*	NONE	**NONE**	NONE	NONE
Yellow Metal	scalar	Visual*	NONE	**NONE**	NONE	NONE
Precipitate	scalar	Visual*	NONE	**NONE**	NONE	NONE
Silt	scalar	Visual*	NONE	**VLITE**	NONE	NONE
Debris	scalar	Visual*	NONE	**NONE**	NONE	NONE
Sand/Dirt	scalar	Visual*	NONE	**NONE**	NONE	NONE
Appearance	scalar	Visual*	NORML	**NORML**	NORML	NORML
Odor	scalar	Visual*	NORML	**NORML**	NORML	NORML
Emulsified Water	scalar	Visual*	>0.05	**NEG**	NEG	NEG
Free Water	scalar	Visual*		**NEG**	NEG	NEG

We advise that you perform a filter service, and use off-line filtration to improve the cleanliness of the system fluid. We recommend an early resample to monitor this condition. NOTE: Please provide information regarding reservoir capacity, filter type and micron rating with next sample.
