Area
Infasco - I02400
Machine Id
A2308159
Component
Unknown Component
Fluid
CHEM-ECOL CHEMKUT 1002 (--- GAL)

Customer Id: CHECOB
Sample No.: E30000164
Lab Number: 02579684
Test Package: IND 2

OIL ANALYSIS REPORT

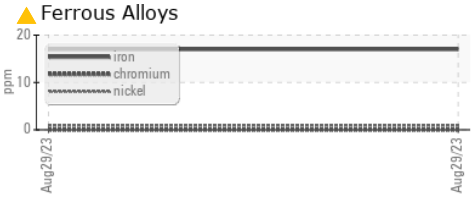
Ferrous Alloys

Sample Status				**ATTENTION**	---	---
Iron	ppm	ASTM D5185(m)		▲ **17**	---	---

Wear
Copper and iron ppm levels are noted.
