Customer Id: ONTQUE
Sample No.: WC0565989
Lab Number: 02579810
Test Package: IND 2

OIL ANALYSIS REPORT

Area
SAB2
Machine Id
SOUTH CRANE AUX HOIST GEARBOX
Component
Gearbox
Fluid
NOT GIVEN (--- GAL)

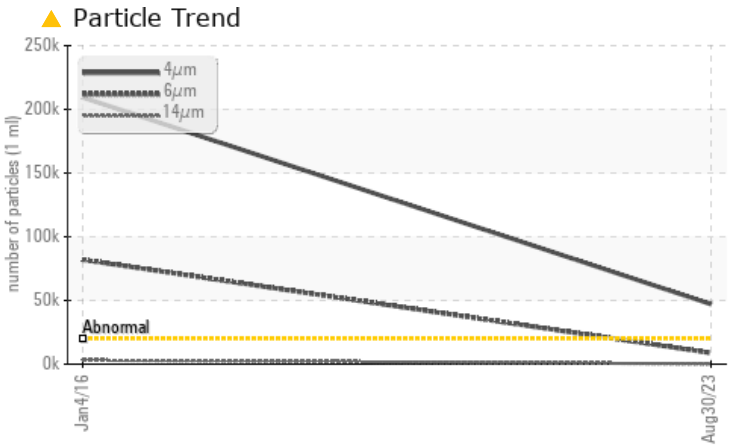
COMPONENT CONDITION SUMMARY

Sample Status				**ABNORMAL**	SEVERE	---
Particles >4µm		ASTM D7647	>20000	**47083**	209406	---
Particles >6µm		ASTM D7647	>5000	**8769**	81986	---
Oil Cleanliness		ISO 4406 (c)	>21/19/16	**23/20/14**	25/24/19	---

There is a moderate amount of silt (particulates < 14 microns in size) present in the oil.

Action	Status	Date	Done By	Description
Change Filter	---	---	?	We recommend you service the filters on this component.
Resample	---	---	?	We recommend an early resample to monitor this condition.
Alert	---	---	?	Little or no information is provided as to the component and lubricant being tested. Recommendations are therefore generic in nature and may not apply to the current application. Please forward information as to equipment type, reservoir capacity, lubricant type and any pertinent information to allow for a more accurate assessment.
Information Required	---	---	?	Please specify the brand, type, and viscosity of the oil on your next sample. NOTE: Please provide information regarding reservoir capacity, filter type and micron rating with next sample.

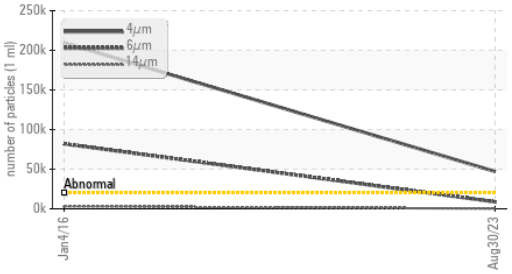
Particle Trend

FLUID CLEANLINESS		method	limit/base	current	history1	history2
Particles >4µm		ASTM D7647	>20000	▲ **47083**	⬢ 209406	---
Particles >6µm		ASTM D7647	>5000	▲ **8769**	⬢ 81986	---
Particles >14µm		ASTM D7647	>640	**139**	▲ 3104	---
Particles >21µm		ASTM D7647	>160	**27**	▲ 693	---
Particles >38µm		ASTM D7647	>40	**10**	49	---
Particles >71µm		ASTM D7647	>10	**9**	4	---
Oil Cleanliness		ISO 4406 (c)	>21/19/16	▲ **23/20/14**	⬢ 25/24/19	---
