PROBLEM SUMMARY

Area
SAB2
Machine Id
SAB2 South Main Gearbox
Component
Gearbox
Fluid
GEAR OIL (PAG) ISO 220 (--- LTR)

Customer Id: ONTQUE
Sample No.: WC0565988
Lab Number: 02579812
Test Package: IND 2

OIL ANALYSIS REPORT

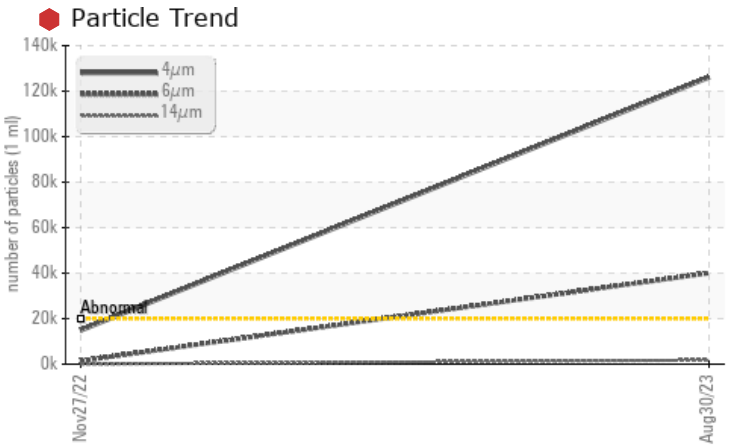
COMPONENT CONDITION SUMMARY

Sample Status				**SEVERE**	NORMAL	---
Particles >4µm		ASTM D7647	>20000	▲ **126073**	14829	---
Particles >6µm		ASTM D7647	>5000	⬢ **40032**	1429	---
Particles >14µm		ASTM D7647	>640	▲ **1753**	18	---
Particles >21µm		ASTM D7647	>160	▲ **505**	5	---
Oil Cleanliness		ISO 4406 (c)	>21/19/16	⬢ **24/23/18**	21/18/11	---

Action	Status	Date	Done By	Description
Change Filter	---	---	?	We advise that you perform a filter service, and use off-line filtration to improve the cleanliness of the system fluid.
Resample	---	---	?	Resample in 30-45 days to monitor this situation.
Alert	---	---	?	Little or no information is provided as to the component and lubricant being tested. Recommendations are therefore generic in nature and may not apply to the current application. Please forward information as to equipment type, reservoir capacity, lubricant type and any pertinent information to allow for a more accurate assessment.
Information Required	---	---	?	NOTE: Please provide information regarding reservoir capacity, filter type and micron rating with next sample.
Check Breathers	---	---	?	The air breather requires service. If unrated, we recommend that you replace with a suitable micron rated and/or desiccant air breather. If rated, we recommend that you service/replace the breather.

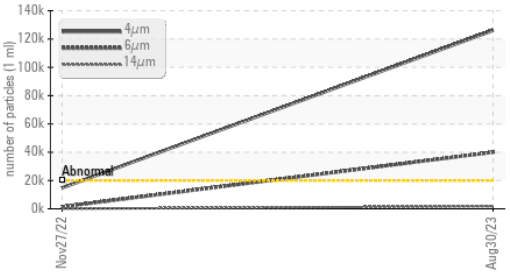
Particle Trend

There is a high amount of particulates (2 to 100 microns in size) present in the oil.

FLUID CLEANLINESS		method	limit/base	current	history1	history2
Particles >4µm		ASTM D7647	>20000	▲ **126073**	14829	---
Particles >6µm		ASTM D7647	>5000	⬢ **40032**	1429	---
Particles >14µm		ASTM D7647	>640	▲ **1753**	18	---
Particles >21µm		ASTM D7647	>160	▲ **505**	5	---
Particles >38µm		ASTM D7647	>40	**21**	0	---
Particles >71µm		ASTM D7647	>10	**2**	0	---
Oil Cleanliness		ISO 4406 (c)	>21/19/16	⬢ **24/23/18**	21/18/11	---

Check Dirt Access	---	---	?	We advise that you check all areas where contaminants can enter the system.
Filter Fluid	---	---	?	We advise that you perform a filter service, and use off-line filtration to improve the cleanliness of the system fluid.

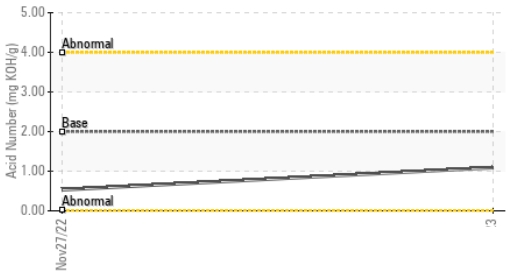
The AN level is acceptable for this fluid. The oil is still serviceable provided that the contaminant(s) can be reduced to acceptable levels.

FLUID DEGRADATION		method	limit/base	current	history1	history2
Acid Number (AN)	mg KOH/g	ASTM D974*	2.00	**1.09**	0.53	---

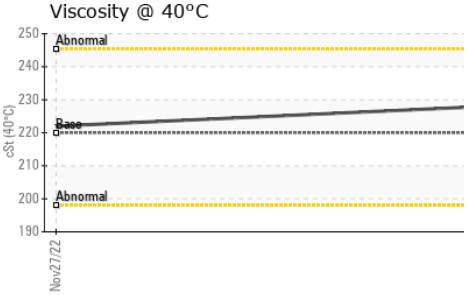
Viscosity @ 40°C

FLUID PROPERTIES		method	limit/base	current	history1	history2
Visc @ 40°C	cSt	ASTM D7279(m)	220	**228**	222	---

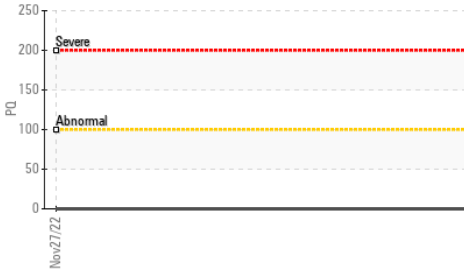
WEAR METALS		method	limit/base	current	history1	history2
PQ		ASTM D8184*		**0**	0	---
Iron	ppm	ASTM D5185(m)	>200	**2**	2	---
Chromium	ppm	ASTM D5185(m)	>15	**0**	0	---
Nickel	ppm	ASTM D5185(m)	>15	**0**	0	---
Titanium	ppm	ASTM D5185(m)		**0**	0	---
Silver	ppm	ASTM D5185(m)		**0**	0	---
Aluminum	ppm	ASTM D5185(m)	>25	**<1**	0	---
Lead	ppm	ASTM D5185(m)	>100	**30**	0	---
Copper	ppm	ASTM D5185(m)	>200	**12**	0	---
Tin	ppm	ASTM D5185(m)	>25	**1**	0	---
Antimony	ppm	ASTM D5185(m)	>5	**0**	0	---
Vanadium	ppm	ASTM D5185(m)		**0**	0	---
Beryllium	ppm	ASTM D5185(m)		**0**	0	---
Cadmium	ppm	ASTM D5185(m)		**0**	0	---

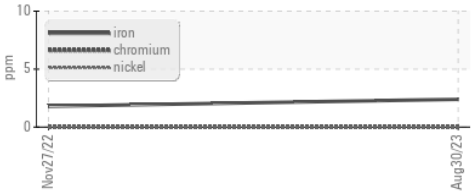
Ferrous Alloys

All component wear rates are normal.
