Area
[02437560]
Machine Id
A2 - Governor Oil Sump
Component
Governor System
Fluid
PETRO CANADA TURBOFLO R&O 46 (6080 LTR)

Customer Id: CHUCHU
Sample No.: WC0669286
Lab Number: 02579993
Test Package: AOM 3

OIL ANALYSIS REPORT

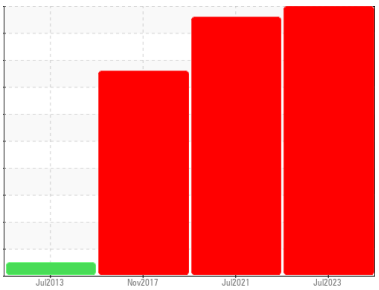
Sample Rating Trend

OFF SPEC

Sample Status				**SEVERE**	SEVERE	SEVERE
Foam Tendency	I/II/III	ASTM D892*	10	**540/60/510**	540/60/530	560/60/500
Foam Stability	I/II/III	ASTM D892*	0	**120/0/0**	60/0/30	90/0/15

We recommend that you perform vacuum distillation and/or air drying to attempt to remove any residual water and/or entrained gases from this oil that may be contributing to abnormal foaming and/or poor water separability. We recommend that you investigate the system for introduction of a surfactant to the reservoir. Some potential surfactants include incorrect oil make-up with an oil containing emulsifying agents (engine oil, compressor oil, gear oil), or soaps entering the system after wash down. We recommend an early resample to monitor this condition.

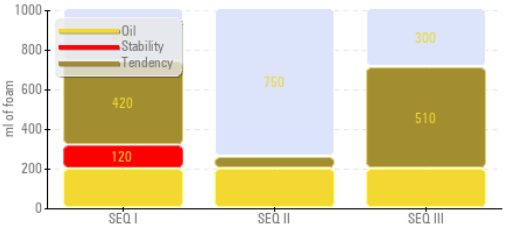
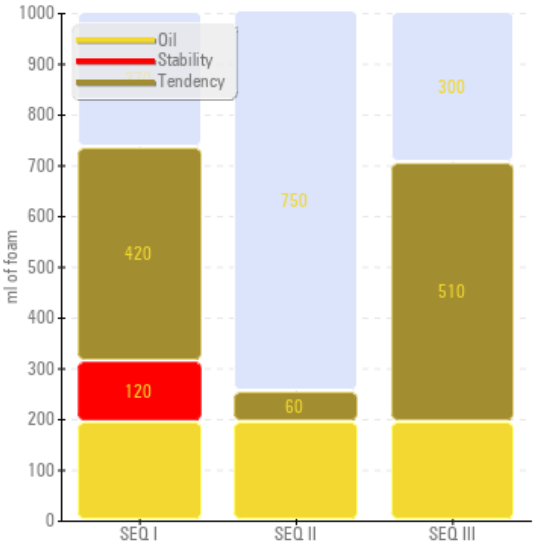
Foaming SEQ I/II/III

Foaming Stability stage I (ASTM D892) result is abnormal indicating an oil foaming problem that could lead to erratic operation. Rust Prevention test (ASTM D665) indicates the oil retains good anti-corrosion properties. The AN level is acceptable for this fluid.

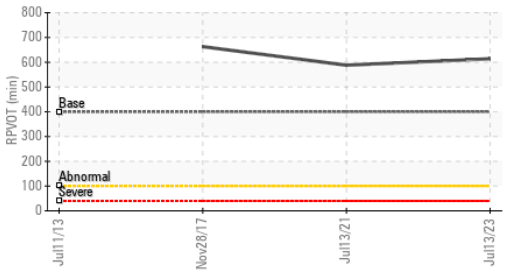
RPVOT

FLUID PROPERTIES		method	limit/base	current	history1	history2
Visc @ 40°C	cSt	ASTM D7279(m)	44.4	**45.4**	45.9	46.0
Visc @ 100°C	cSt	ASTM D7279(m)	6.72	**6.8**	6.8	6.8
Viscosity Index (VI)	Scale	ASTM D2270*	104	**103**	101	101
Separability	oil/h2o/em	ASTM D1401*	41/39/0	**42/38/0 (25)**	41/39/0 (25)	41/39/0 (30)
Air Release Time	min	ASTM D3427*	3.5	**6.40**	7.10	▲ 10.13
Foam Tendency	I/II/III	ASTM D892*	10	▲ **540/60/510**	▲ 540/60/530	▲ 560/60/500
Foam Stability	I/II/III	ASTM D892*	0	⬢ **120/0/0**	⬢ 60/0/30	⬢ 90/0/15
ASTM Color	scalar	ASTM D1500*	0.5	**L1.0**	<1.5	1.0
Rust Prevention	PASS/FAIL	ASTM D665*	PASS	**PASS**	PASS	PASS
Oxidation Test (RPVOT)	minutes	ASTM D2272*	400	**614**	588	663

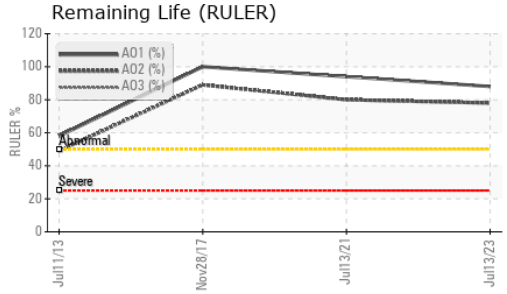
Remaining Life (RULER)

FLUID DEGRADATION		method	limit/base	current	history1	history2
Oxidation	Abs/.1mm	ASTM D7414*		**2.2**	2.4	---
Acid Number (AN)	mg KOH/g	ASTM D974*	0.12	**0.09**	0.10	0.105
Anti-Oxidant 1	%	ASTM D6971*	<25	**88**	94	100
Anti-Oxidant 2	%	ASTM D6971*	<25	**78**	80	89
MPC Varnish Potential	Scale	ASTM D7843(m)*	>15	**3**	5	5

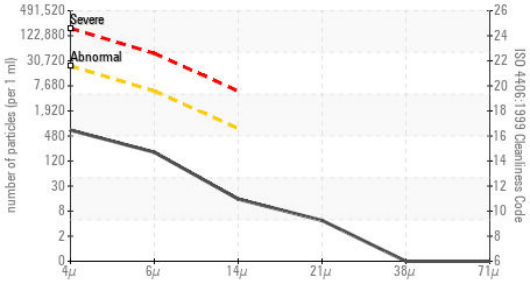
Particle Count

The system cleanliness is acceptable for your target ISO 4406 cleanliness code. The water content is negligible. The system and fluid cleanliness is acceptable.

FLUID CLEANLINESS	method	limit/base	current	history1	history2
Particles >4µm	ASTM D7647	>20000	**582**	1894	1167
Particles >6µm	ASTM D7647	>5000	**172**	318	220
Particles >14µm	ASTM D7647	>640	**13**	25	23
Particles >21µm	ASTM D7647	>160	**4**	8	6
Particles >38µm	ASTM D7647	>40	**0**	0	0
Particles >71µm	ASTM D7647	>10	**0**	0	0
Oil Cleanliness	ISO 4406 (c)	>21/19/16	**16/15/11**	18/15/12	17/15/12

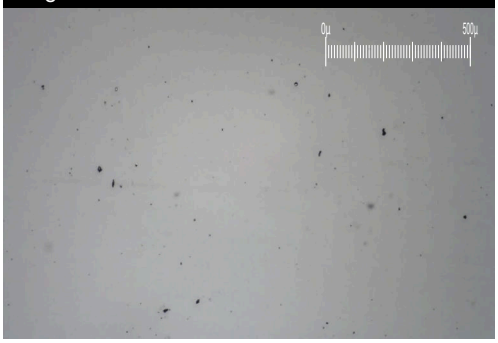
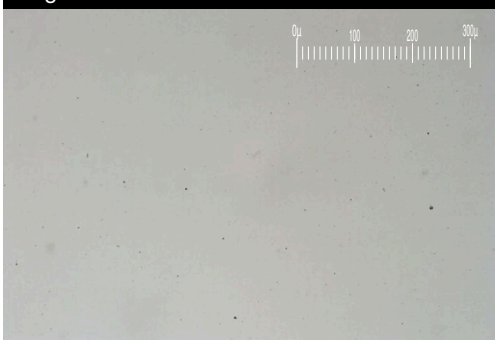
FERROGRAPHY REPORT

All component wear rates are normal. The direct-reading & analytical ferrographic results are normal indicating no abnormal wear in the system.
