Area
[02437560]
Machine Id
A4 - Thrust Bearing
Component
Thrust Bearing
Fluid
PETRO CANADA TURBOFLO R&O 46 (5705 LTR)

Customer Id: CHUCHU
Sample No.: WC0679960
Lab Number: 02579997
Test Package: AOM 3

OIL ANALYSIS REPORT

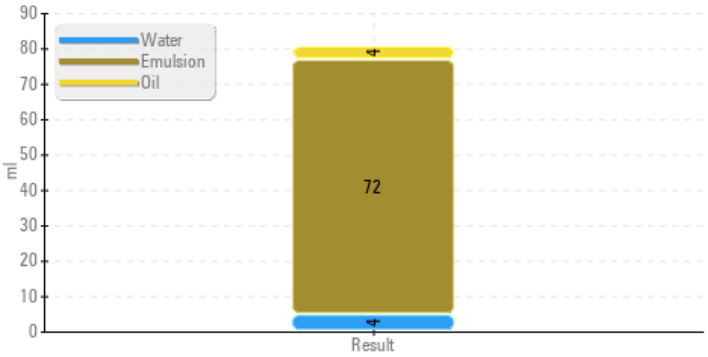
Water Separability results (ASTM D1401) are poor and indicate that the oil will form emulsions with water. The system cleanliness is acceptable for your target ISO 4406 cleanliness code. The water content is negligible.

We recommend that you perform vacuum distillation and/or air drying to attempt to remove any residual water and/or entrained gases from this oil that may be contributing to abnormal foaming and/or poor water separability. We recommend that you drain the oil from the component if this has not already been done. We recommend an early resample to monitor this condition.

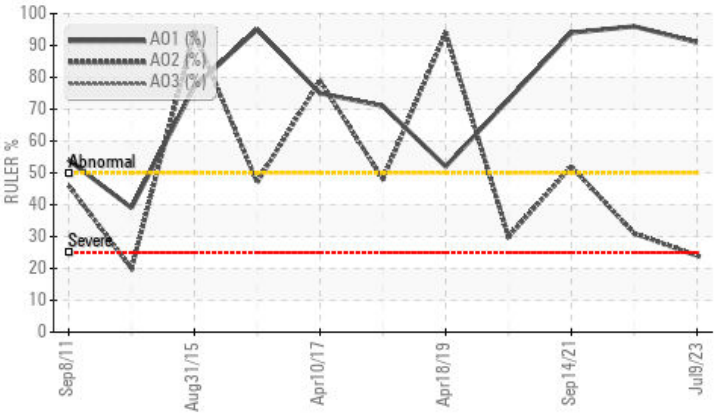
Remaining Life (RULER)

Foaming Tendency stage I (ASTM D892) result is abnormal indicating a tendency for oil foaming. Linear Sweep Voltammetry (RULER– ASTM D6971) testing indicates a low amount of one of the anti-oxidants present in the oil, however, the other anti-oxidant(s) are still performing adequately. Rust Prevention test (ASTM D665) indicates the oil retains good anti-corrosion properties. The AN level is acceptable for this fluid.

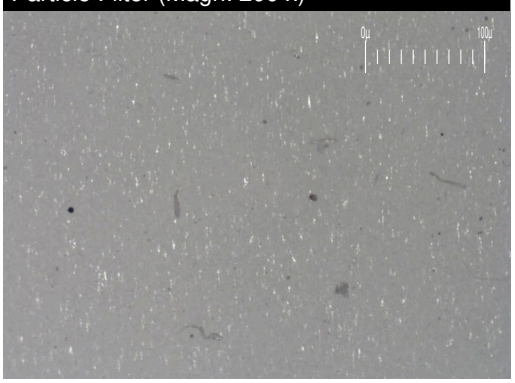
Particle Filter (Magn: 200 x)

Wear particle analysis indicates that the ferrous spheres and ferrous rolling particles are abnormal. Bearing wear is indicated.

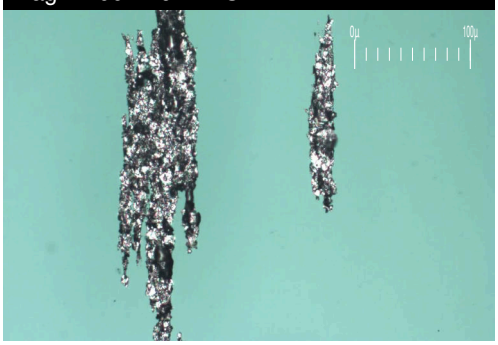
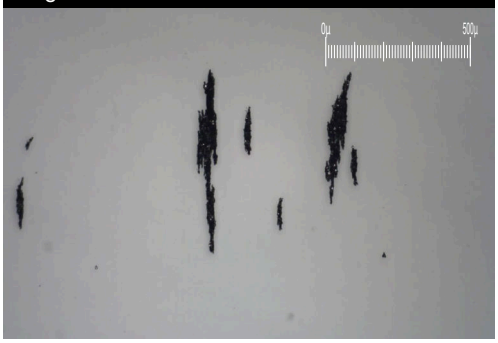
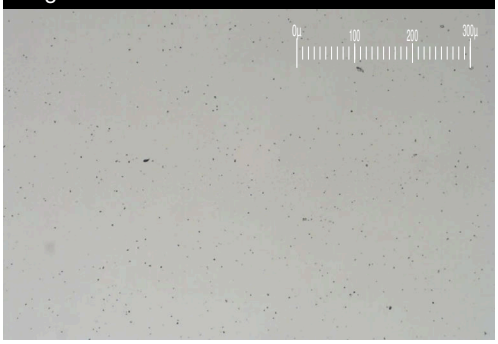
Wear particle analysis indicates that the ferrous spheres and ferrous rolling particles are abnormal. Bearing wear is indicated.
