Area
[02437560]
Machine Id
A3 - Governor Oil Sump
Component
Governor System
Fluid
PETRO CANADA TURBOFLO R&O 46 (6080 LTR)

Customer Id: CHUCHU
Sample No.: WC0786872
Lab Number: 02580005
Test Package: AOM 3

OIL ANALYSIS REPORT

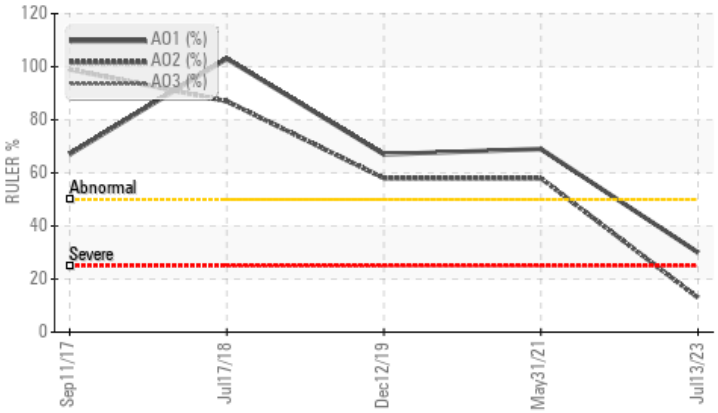
▲ Remaining Life (RULER)

Foaming Tendency (ASTM D892) results are abnormal indicating a tendency for oil foaming. Linear Sweep Voltammetry (RULER– ASTM D6971) testing indicates a low amount of one of the anti-oxidants present in the oil, however, the other anti-oxidant(s) are still performing adequately. Rust Prevention test (ASTM D665) indicates the oil retains good anti-corrosion properties. The AN level is acceptable for this fluid.

We recommend that you perform vacuum distillation and/or air drying to attempt to remove any residual water and/or entrained gases from this oil that may be contributing to abnormal foaming and/or poor water separability. We recommend an early resample to monitor this condition. No other corrective action is recommended at this time.

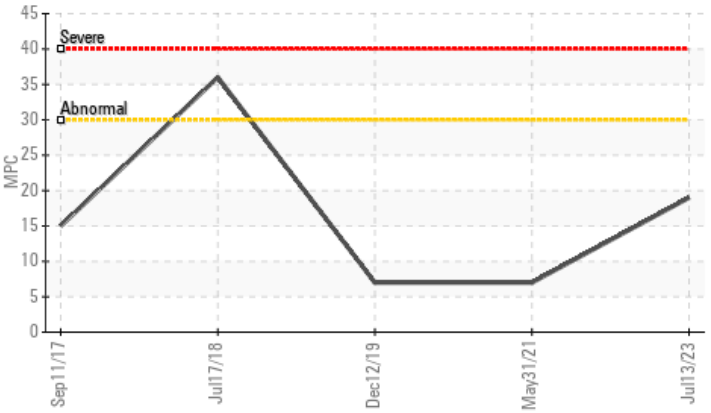
▲ Varnish Potential

MPC (Membrane Patch Colorimetry) test indicates a light concentration of varnish present. The water content is negligible.

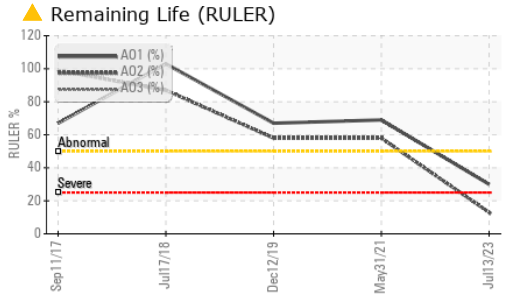
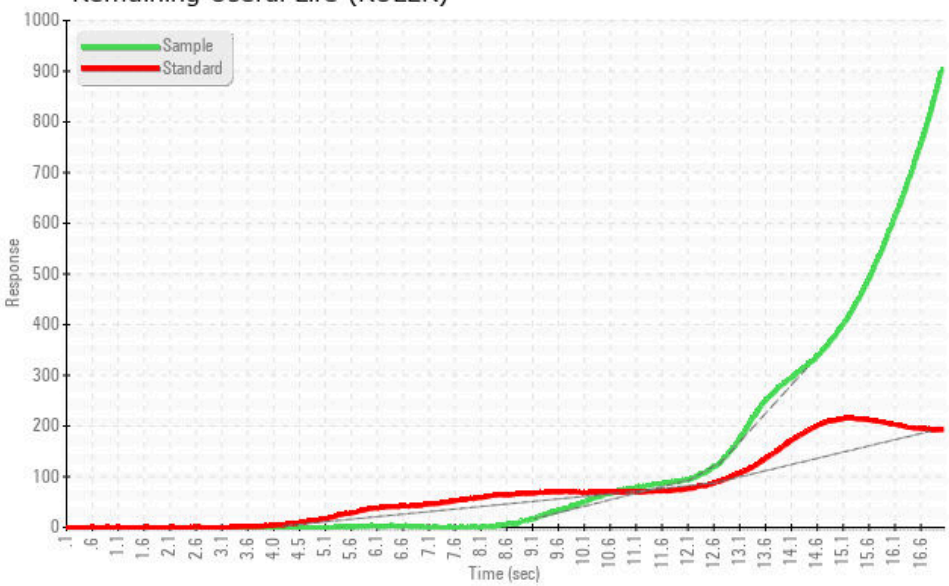
▲ Remaining Life (RULER)

Sample Status				**ABNORMAL**	ABNORMAL	ABNORMAL
Anti-Oxidant 2	%	ASTM D6971*	<25	▲ **13**	58	58
MPC Varnish Potential	Scale	ASTM D7843(m)*	>15	▲ **19**	7	7
Foam Tendency	I/II/III	ASTM D892*	10	▲ **510/60/470**	▲ 520/50/500	▲ 485/50/410

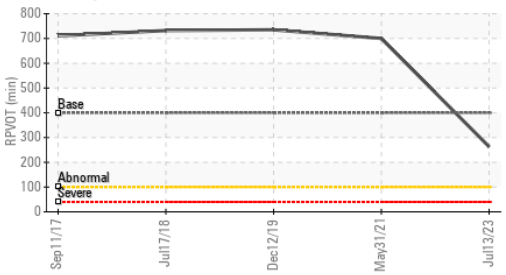
RPVOT

FLUID PROPERTIES		method	limit/base	current	history1	history2
Visc @ 40°C	cSt	ASTM D7279(m)	44.4	**45.0**	45.0	45.4
Visc @ 100°C	cSt	ASTM D7279(m)	6.72	**6.7**	6.8	6.7
Viscosity Index (VI)	Scale	ASTM D2270*	104	**101**	105	99
Separability	oil/h2o/em	ASTM D1401*	41/39/0	**42/38/0 (25)**	41/39/0 (20)	41/39/0 (15)
Air Release Time	min	ASTM D3427*	3.5	**5.80**	4.80	6.70
Foam Tendency	I/II/III	ASTM D892*	10	▲ **510/60/470**	▲ 520/50/500	▲ 485/50/410
Foam Stability	I/II/III	ASTM D892*	0	**0/0/0**	0/0/0	0/0/0
ASTM Color	scalar	ASTM D1500*	0.5	**L2.0**	<1.0	<0.5
Rust Prevention	PASS/FAIL	ASTM D665*	PASS	**PASS**	PASS	PASS
Oxidation Test (RPVOT)	minutes	ASTM D2272*	400	**263**	700	735

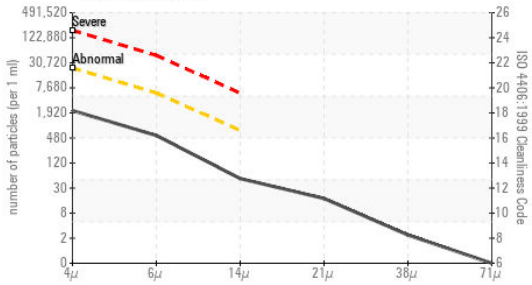
Particle Count

FLUID CLEANLINESS	method	limit/base	current	history1	history2
Particles >4µm	ASTM D7647	>20000	**1913**	2434	▲ 39286
Particles >6µm	ASTM D7647	>5000	**484**	468	4018
Particles >14µm	ASTM D7647	>640	**45**	39	124
Particles >21µm	ASTM D7647	>160	**15**	13	40
Particles >38µm	ASTM D7647	>40	**2**	1	2
Particles >71µm	ASTM D7647	>10	**0**	0	0
Oil Cleanliness	ISO 4406 (c)	>21/19/16	**18/16/13**	18/16/12	▲ 22/19/14

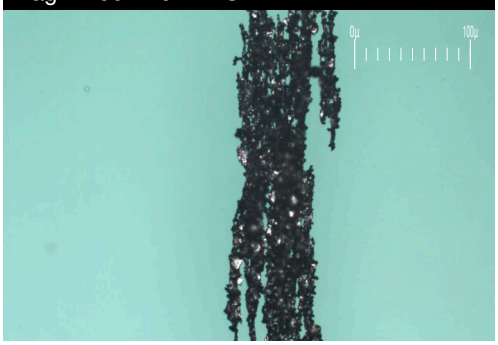
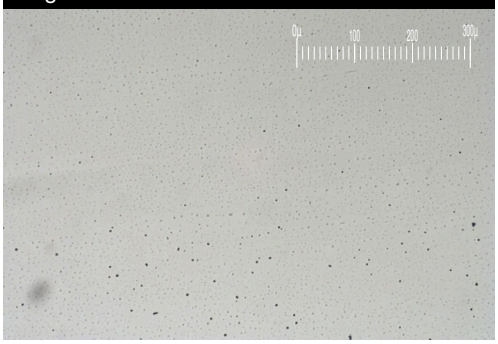
All component wear rates are normal. The direct-reading & analytical ferrographic results are normal indicating no abnormal wear in the system.
