Customer Id: CANESTSK
Sample No.: BR0000787
Lab Number: 02585964
Test Package: IND 1

OIL ANALYSIS REPORT

Machine Id
1570B DRAG #1
Component
1 Gearbox
Fluid
BELRAY 100 EP GEAR OIL 680 (70 GAL)

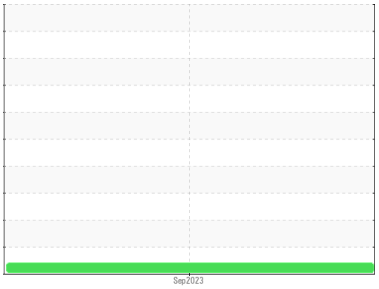
Sample Rating Trend

Sample Status				**ABNORMAL**	---	---
Visc @ 40°C	cSt	ASTM D7279(m)	688	▲ **502**	---	---

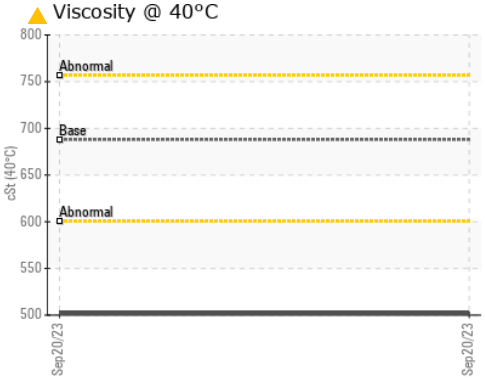
▲ Viscosity @ 40°C

Fluid Condition
Viscosity of sample indicates oil is within ISO 460 range, advise investigate. This plus the additive levels indicates that this is not the same brand, or type of oil as reported. The condition of the oil is acceptable for the time in service.

FLUID PROPERTIES		method	limit/base	current	history1	history2
Visc @ 40°C	cSt	ASTM D7279(m)	688	▲ **502**	---	---

Confirm the source of the lubricant being utilized for top-up/fill. Resample at the next service interval to monitor.
