PROBLEM SUMMARY

Area
Direct Strip Mill/Caster
Machine Id
CH2.3 HYDRAULIC SYSTEM (DSC025) (S/N 1000024463)
Component
Hydraulic System
Fluid
HOUGHTON HOUGHTO-SAFE 620 (4500 LTR)

Customer Id: ALGSSM
Sample No.: WC0837300
Lab Number: 02586210
Test Package: IND 2

OIL ANALYSIS REPORT

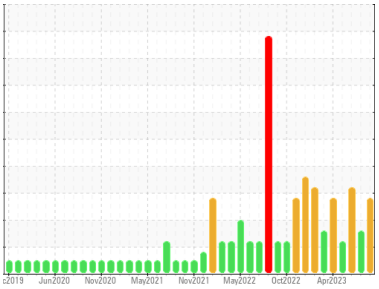
Sample Rating Trend

DEGRADATION

Sample Status				**ABNORMAL**	ABNORMAL	ABNORMAL
Particles >4µm		ASTM D7647	>640	▲ **689**	353	▲ 830
Particles >6µm		ASTM D7647	>160	▲ **215**	▲ 177	▲ 199
Particles >21µm		ASTM D7647	>4	▲ **7**	▲ 15	▲ 9
Oil Cleanliness		ISO 4406 (c)	>16/14/11	▲ **17/15/11**	▲ 16/15/13	▲ 17/15/12
Alkiline Reserve (Oils)	ml KOH/g	ASTM D1121*	125	▲ **93**	122	▲ 101

Due to the low reserve alkalinity it is advised that you contact HOUGHTON to assist in restoring the proper amine concentration. We recommend you service the filters on this component. We recommend an early resample to monitor this condition. Please note that this is a corrected copy for data entry updates.

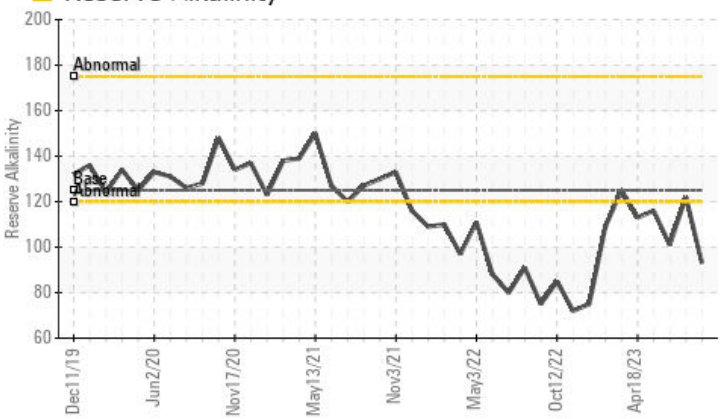
Reserve Alkalinity

The reserve alkalinity of this fluid is lower than acceptable. The AN level is acceptable for this fluid. The pH level of this fluid is within the acceptable limits. The water concentration level is acceptable for this fluid.

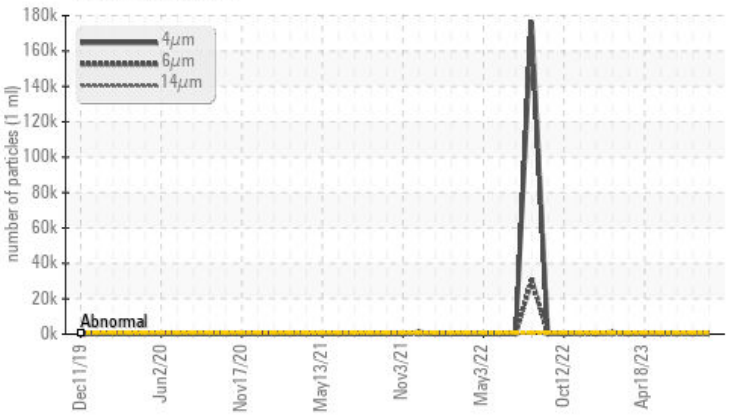
Particle Trend

There is a light amount of silt (particulates < 14 microns in size) present in the oil.

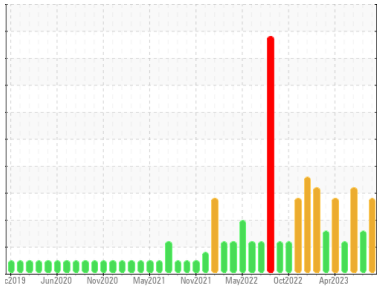
Sample Rating Trend

DEGRADATION

Due to the low reserve alkalinity it is advised that you contact HOUGHTON to assist in restoring the proper amine concentration. We recommend you service the filters on this component. We recommend an early resample to monitor this condition. Please note that this is a corrected copy for data entry updates.

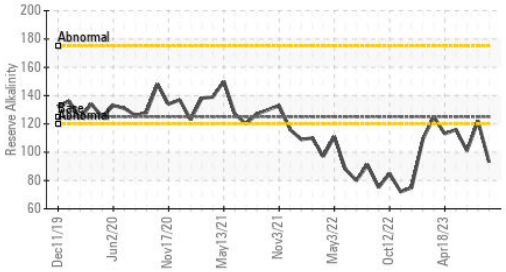
Reserve Alkalinity

FLUID DEGRADATION		method	limit/base	current	history1	history2
Acid Number (AN)	mg KOH/g	ASTM D974*		**5.49**	5.06	5.44
Alkiline Reserve (Oils)	ml KOH/g	ASTM D1121*	125	▲ **93**	122	▲ 101

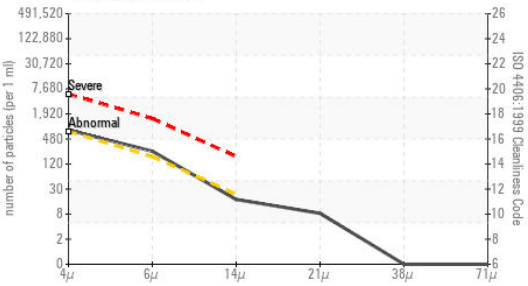
Particle Count

FLUID CLEANLINESS		method	limit/base	current	history1	history2
Particles >4µm		ASTM D7647	>640	▲ **689**	353	▲ 830
Particles >6µm		ASTM D7647	>160	▲ **215**	▲ 177	▲ 199
Particles >14µm		ASTM D7647	>20	**15**	▲ 51	▲ 28
Particles >21µm		ASTM D7647	>4	▲ **7**	▲ 15	▲ 9
Particles >38µm		ASTM D7647	>3	**0**	2	2
Particles >71µm		ASTM D7647	>3	**0**	0	0
Oil Cleanliness		ISO 4406 (c)	>16/14/11	▲ **17/15/11**	▲ 16/15/13	▲ 17/15/12
