PROBLEM SUMMARY

Area
Direct Strip Mill/Caster
Machine Id
CH2.4 HYDRAULIC SYSTEM (DSC193) (S/N 1000024515)
Component
Hydraulic System
Fluid
HOUGHTON HOUGHTO-SAFE 620 (2730 LTR)

OIL ANALYSIS REPORT

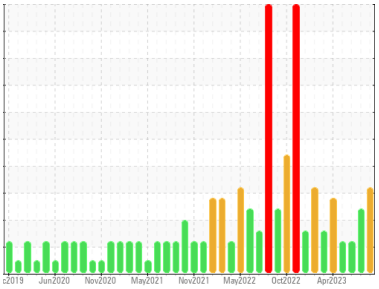
Sample Rating Trend

DEGRADATION

The reserve alkalinity of this fluid is lower than acceptable. The AN level is acceptable for this fluid. The pH level of this fluid is within the acceptable limits. The water concentration level is acceptable for this fluid. The oil is still serviceable provided that the contaminant(s) can be reduced to acceptable levels.

Due to the low reserve alkalinity it is advised that you contact HOUGHTON to assist in restoring the proper amine concentration. We advise that you perform a filter service, and use off-line filtration to improve the cleanliness of the system fluid. We recommend an early resample to monitor this condition. Please note that this is a corrected copy for data entry updates.

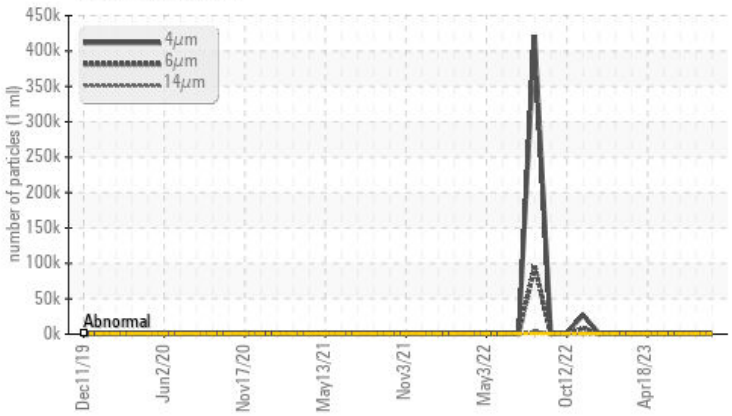
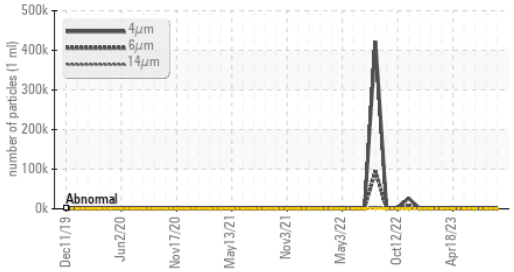
Particle Trend

There is a moderate amount of particulates (2 to 100 microns in size) present in the oil. The system cleanliness is above the acceptable limit for the target ISO 4406 cleanliness code.

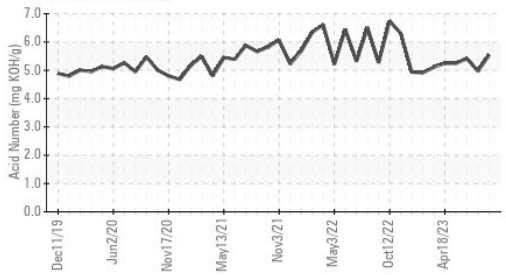
FLUID DEGRADATION		method	limit/base	current	history1	history2
Acid Number (AN)	mg KOH/g	ASTM D974*		**5.54**	4.97	5.41
Alkiline Reserve (Oils)	ml KOH/g	ASTM D1121*	125	▲ **104**	▲ 112	▲ 86
