PROBLEM SUMMARY

Area
Direct Strip Mill/Finishing
Machine Id
PH3 HYDRAULIC SYSTEM (DSC004) (S/N 1000014662)
Component
Hydraulic System
Fluid
HOUGHTON HOUGHTO-SAFE 620 (15000 LTR)

OIL ANALYSIS REPORT

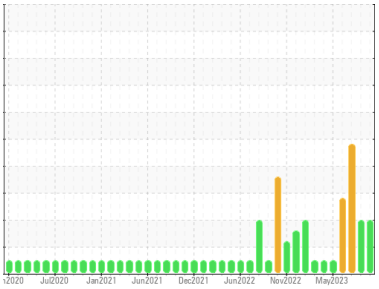
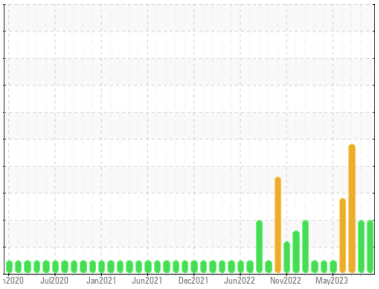
Sample Rating Trend

ISO

Sample Status				ATTENTION	ABNORMAL	SEVERE
Particles >4µm		ASTM D7647	>640	▲ **1031**	▲ 735	⬢ 5797
Particles >6µm		ASTM D7647	>160	▲ **307**	▲ 379	⬢ 1619
Particles >14µm		ASTM D7647	>20	▲ **29**	▲ 85	▲ 71
Particles >21µm		ASTM D7647	>4	▲ **9**	▲ 35	▲ 21
Oil Cleanliness		ISO 4406 (c)	>16/14/11	▲ **17/15/12**	▲ 17/16/14	⬢ 20/18/13

We recommend you service the filters on this component. Resample at the next service interval to monitor. Please note that this is a corrected copy for data entry updates.

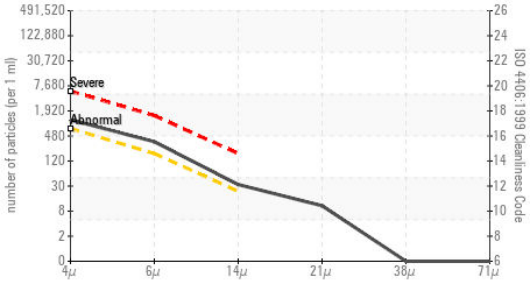
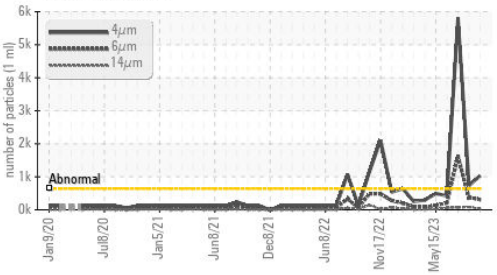
Particle Count

There is a light amount of silt (particulates < 14 microns in size) present in the oil.

FLUID CLEANLINESS		method	limit/base	current	history1	history2
Particles >4µm		ASTM D7647	>640	▲ **1031**	▲ 735	⬢ 5797
Particles >6µm		ASTM D7647	>160	▲ **307**	▲ 379	⬢ 1619
Particles >14µm		ASTM D7647	>20	▲ **29**	▲ 85	▲ 71
Particles >21µm		ASTM D7647	>4	▲ **9**	▲ 35	▲ 21
Particles >38µm		ASTM D7647	>3	**0**	2	▲ 6
Particles >71µm		ASTM D7647	>3	**0**	0	0
Oil Cleanliness		ISO 4406 (c)	>16/14/11	▲ **17/15/12**	▲ 17/16/14	⬢ 20/18/13

We recommend you service the filters on this component. Resample at the next service interval to monitor. Please note that this is a corrected copy for data entry updates.

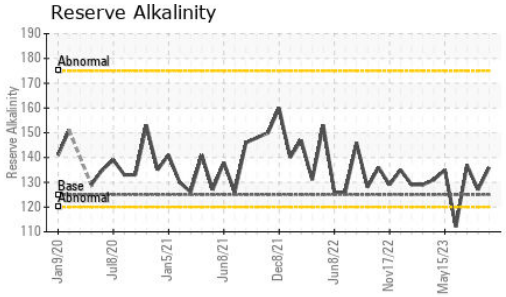
Reserve Alkalinity

The AN level is acceptable for this fluid. The pH level of this fluid is within the acceptable limits. The reserve alkalinity of this fluid is acceptable. The water concentration level is acceptable for this fluid. The condition of the oil is suitable for further service.

FLUID DEGRADATION		method	limit/base	current	history1	history2
Acid Number (AN)	mg KOH/g	ASTM D974*		**4.73**	4.83	4.28
Alkiline Reserve (Oils)	ml KOH/g	ASTM D1121*	125	**136**	127	137
