# OIL ANALYSIS REPORT

Area
## (C-GMCF)
Machine Id
## [C-GMCF] DEHAVILLAND DHC8-514 244
Component
**Jet Turbine**
Fluid
**NOT GIVEN (--- GAL)**

# FERROGRAPHY REPORT

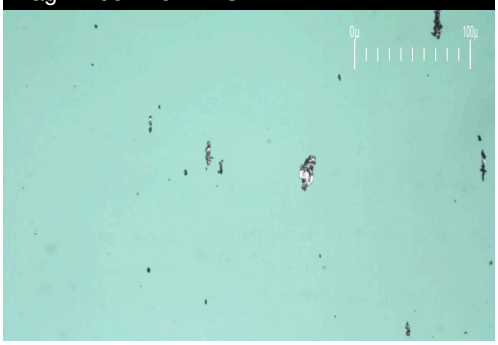
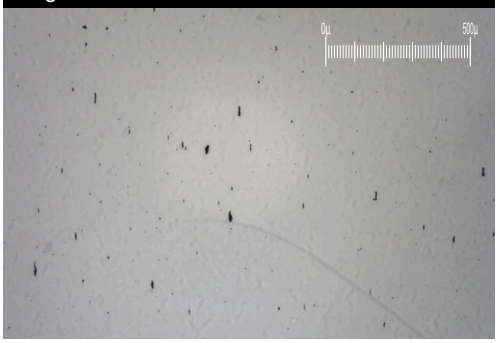
All component wear rates are normal. The direct-reading & analytical ferrographic results are normal indicating no abnormal wear in the system.
