OIL ANALYSIS REPORT

Area
(CGHOD) C-GHOD [C-GHOD 7935.6 AFTT]
Machine Id
[CGHOD] AIRBUS MGB M7444/M4841
Component
Rotor Gearbox
Fluid
ANDEROL ROYCO 586M (6 LTR)

Laboratory : WearCheck - C8-1175 Appleby Line, Burlington, ON L7L 5H9
Sample No. : WC0847673
Lab Number : 02586907
Unique Number : 5655973
Test Package : AVI 3

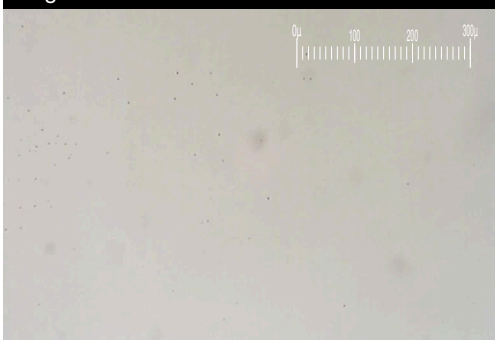
All component wear rates are normal. The direct-reading & analytical ferrographic results are normal indicating no abnormal wear in the system.
