Area
PUMPHOUSE/BOOSTER RAW WATER PUMPS
Machine Id
C - Booster Raw Water Pump Gearbox Oil System
Component
Lube System
Fluid
PETRO CANADA HYDREX AW 100 (45 GAL)

Customer Id: LEWBOSC
Sample No.: WC0866308
Lab Number: 02586916
Test Package: IND 2

OIL ANALYSIS REPORT

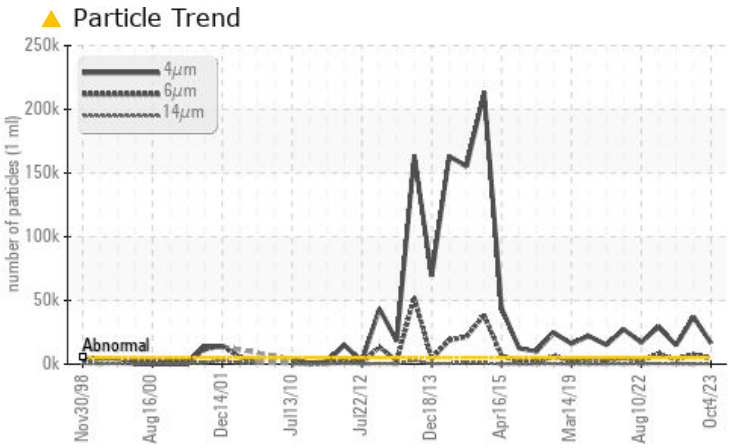
COMPONENT CONDITION SUMMARY

Sample Status				**ABNORMAL**	ABNORMAL	ABNORMAL
Particles >4µm		ASTM D7647	>5000	▲ **16456**	▲ 37111	▲ 14742
Particles >6µm		ASTM D7647	>1300	▲ **4414**	▲ 7635	▲ 3779
Particles >14µm		ASTM D7647	>160	▲ **234**	▲ 181	▲ 276
Oil Cleanliness		ISO 4406 (c)	>19/17/14	▲ **21/19/15**	▲ 22/20/15	▲ 21/19/15

There is a moderate amount of silt (particulates < 14 microns in size) present in the oil. The system cleanliness is above the acceptable limit for the target ISO 4406 cleanliness code.

We recommend you service the filters on this component. We recommend an early resample to monitor this condition.

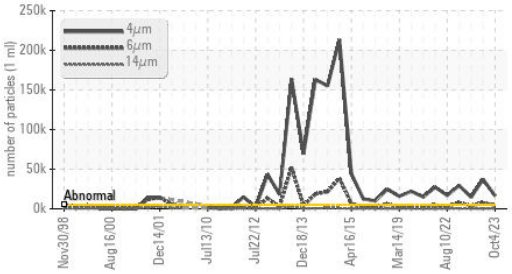
Particle Trend

FLUID CLEANLINESS		method	limit/base	current	history1	history2
Particles >4µm		ASTM D7647	>5000	**16456**	37111	14742
Particles >6µm		ASTM D7647	>1300	**4414**	7635	3779
Particles >14µm		ASTM D7647	>160	**234**	181	276
Particles >21µm		ASTM D7647	>40	**44**	32	71
Particles >38µm		ASTM D7647	>10	**1**	0	2
Particles >71µm		ASTM D7647	>3	**0**	0	0
Oil Cleanliness		ISO 4406 (c)	>19/17/14	**21/19/15**	22/20/15	21/19/15

We recommend you service the filters on this component. We recommend an early resample to monitor this condition.

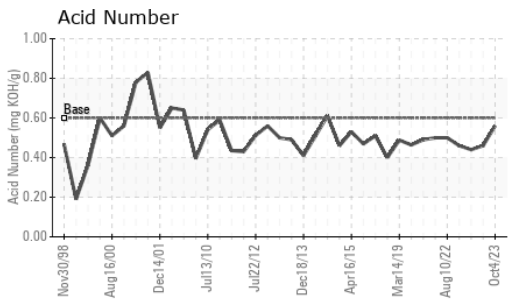
The AN level is acceptable for this fluid. The oil is still serviceable provided that the contaminant(s) can be reduced to acceptable levels.

FLUID DEGRADATION		method	limit/base	current	history1	history2
Acid Number (AN)	mg KOH/g	ASTM D974*	0.60	**0.56**	0.46	0.44

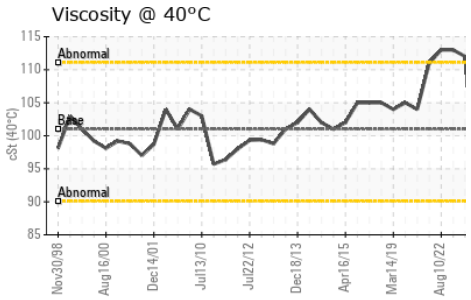
Viscosity @ 40°C

FLUID PROPERTIES		method	limit/base	current	history1	history2
Visc @ 40°C	cSt	ASTM D7279(m)	101	**93.7**	93.2	112
