OIL ANALYSIS REPORT

Area
Inland Iron and Metal - 888041
Machine Id
AG200
Component
Hydraulic System
Fluid
AW HYDRAULIC OIL ISO 46 (--- GAL)

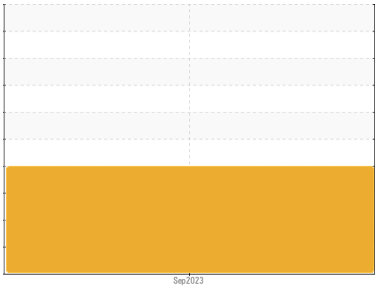
Sample Rating Trend

Sample Status				**SEVERE**	---	---
Particles >4µm		ASTM D7647	>5000	**71267**	---	---
Particles >6µm		ASTM D7647	>1300	**12839**	---	---
Particles >14µm		ASTM D7647	>160	**244**	---	---
Oil Cleanliness		ISO 4406 (c)	>19/17/14	**23/21/15**	---	---

This is a baseline read-out on the submitted sample.

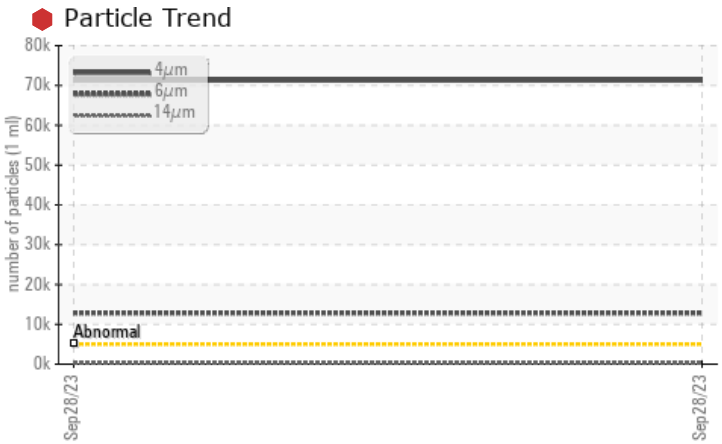
COMPONENT CONDITION SUMMARY

Contamination
Particles >6µm are severely high. Particles >4µm are severely high. Oil Cleanliness are severely high. Particles >14µm are notably high.

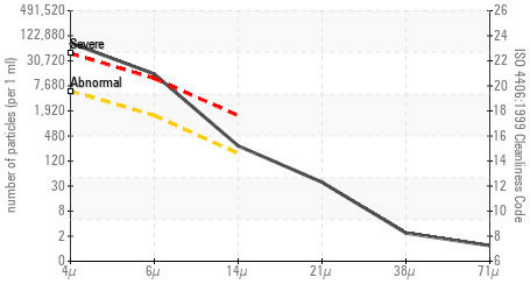
Particle Count

FLUID CLEANLINESS		method	limit/base	current	history1	history2
Particles >4µm		ASTM D7647	>5000	**71267**	---	---
Particles >6µm		ASTM D7647	>1300	**12839**	---	---
Particles >14µm		ASTM D7647	>160	**244**	---	---
Particles >21µm		ASTM D7647	>40	**33**	---	---
Particles >38µm		ASTM D7647	>10	**2**	---	---
Particles >71µm		ASTM D7647	>3	**1**	---	---
Oil Cleanliness		ISO 4406 (c)	>19/17/14	**23/21/15**	---	---

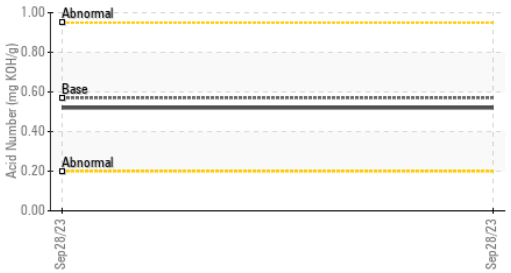
FLUID DEGRADATION		method	limit/base	current	history1	history2
Acid Number (AN)	mg KOH/g	ASTM D974*	0.57	**0.52**	---	---
