PROBLEM SUMMARY

Area
(ZONE3) BRUCE A/1/34710
Machine Id
1-34710-P2-P OB Ball/Sleeve
Component
Outboard Bearing
Fluid
MOBIL DTE 732 (--- GAL)

OIL ANALYSIS REPORT

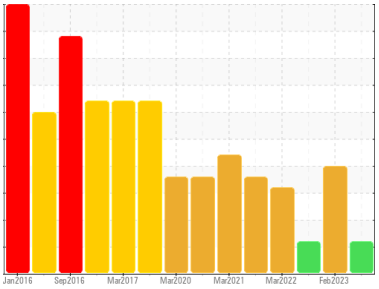
Sample Rating Trend

Sample Status				**ABNORMAL**	SEVERE	ABNORMAL
Particles >4µm		ASTM D7647	>5000	▲ **11988**	⬢ 67096	▲ 27975
Particles >6µm		ASTM D7647	>1300	▲ **2724**	⬢ 13403	▲ 3690
Oil Cleanliness		ISO 4406 (c)	>19/17/15	▲ **21/19/14**	⬢ 23/21/16	▲ 22/19/14

We recommend you service the filters on this component. We recommend an early resample to monitor this condition. NOTE: Please provide information regarding reservoir capacity, filter type and micron rating with next sample.

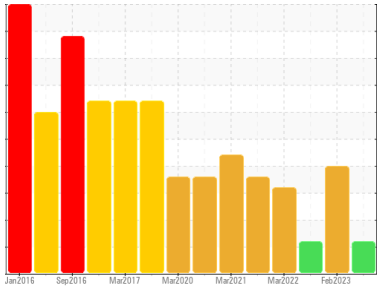
Sample Rating Trend

There is a moderate amount of silt (particulates < 14 microns in size) present in the oil. The water content is negligible. The system cleanliness is above the acceptable limit for the target ISO 4406 cleanliness code.

The AN level is acceptable for this fluid. The oil is still serviceable provided that the contaminant(s) can be reduced to acceptable levels.

We recommend you service the filters on this component. We recommend an early resample to monitor this condition. NOTE: Please provide information regarding reservoir capacity, filter type and micron rating with next sample.

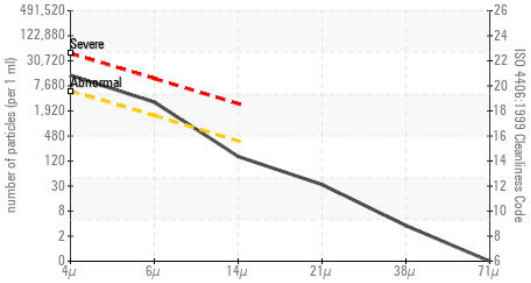
Particle Count

FLUID CLEANLINESS	method	limit/base	current	history1	history2
Particles >4µm	ASTM D7647	>5000	▲ **11988**	⬢ 67096	▲ 27975
Particles >6µm	ASTM D7647	>1300	▲ **2724**	⬢ 13403	▲ 3690
Particles >14µm	ASTM D7647	>320	**136**	▲ 556	98
Particles >21µm	ASTM D7647	>80	**29**	88	20
Particles >38µm	ASTM D7647	>20	**3**	1	0
Particles >71µm	ASTM D7647	>4	**0**	0	0
Oil Cleanliness	ISO 4406 (c)	>19/17/15	▲ **21/19/14**	⬢ 23/21/16	▲ 22/19/14

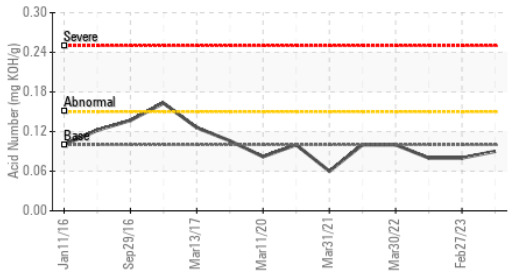
FLUID DEGRADATION		method	limit/base	current	history1	history2
Acid Number (AN)	mg KOH/g	ASTM D974*	0.10	**0.09**	0.08	0.08

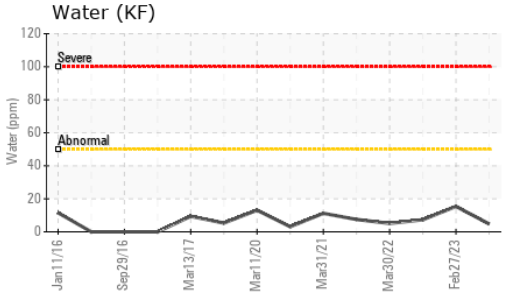
Water (KF)

CONTAMINANTS		method	limit/base	current	history1	history2
Silicon	ppm	ASTM D5185(m)	>5	**0**	0	0
Sodium	ppm	ASTM D5185(m)	>5	**<1**	0	0
Potassium	ppm	ASTM D5185(m)	>20	**0**	0	<1
Water	%	ASTM D6304*	>0.005	**0.001**	0.002	0.001
ppm Water	ppm	ASTM D6304*	>50	**4.8**	15.4	7.3

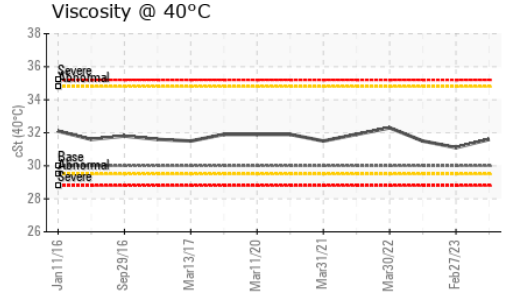
Viscosity @ 40°C

FLUID PROPERTIES		method	limit/base	current	history1	history2
Visc @ 40°C	cSt	ASTM D7279(m)	30.0	**31.6**	31.1	31.5
