Area
3 Calender Line
Machine Id
42-0319 Bastian Hyd
Component
Hydraulic System
Fluid
SUNOCO SUNVIS 846 ISO 46 (170 GAL)

Customer Id: CAN52CAM
Sample No.: WC0837256
Lab Number: 02587582
Test Package: IND 2

OIL ANALYSIS REPORT

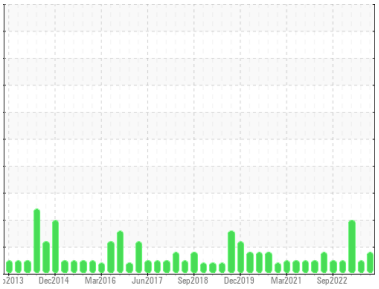
Sample Rating Trend

ATTENTION	NORMAL	ABNORMAL
Sample Status						
Particles >6µm		ASTM D7647	>1300	▲ **1370**	774	▲ 3152
Oil Cleanliness		ISO 4406 (c)	>19/17/14	▲ **19/18/14**	19/17/12	▲ 21/19/15

Contamination
There is a light amount of silt (particulates < 14 microns in size) present in the oil.

We recommend you service the filters on this component. Resample at the next service interval to monitor.

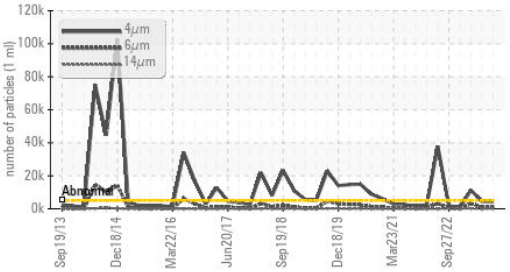
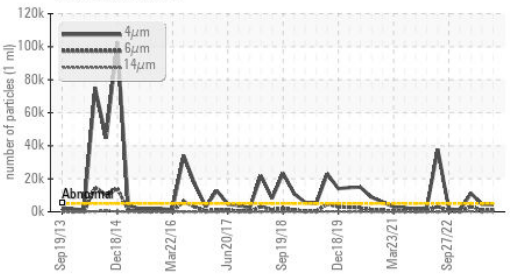
Particle Trend

FLUID CLEANLINESS		method	limit/base	current	history1	history2
Particles >4µm		ASTM D7647	>5000	**4275**	4446	▲ 11234
Particles >6µm		ASTM D7647	>1300	▲ **1370**	774	▲ 3152
Particles >14µm		ASTM D7647	>160	**107**	24	▲ 280
Particles >21µm		ASTM D7647	>40	**24**	8	▲ 77
Particles >38µm		ASTM D7647	>10	**2**	1	3
Particles >71µm		ASTM D7647	>3	**0**	0	0
Oil Cleanliness		ISO 4406 (c)	>19/17/14	▲ **19/18/14**	19/17/12	▲ 21/19/15
