PROBLEM SUMMARY

Area
Plastisol Line
Machine Id
Plastisol Embosser Hydraulic Pump (S/N 59-0835)
Component
Hydraulic System
Fluid
SUNOCO SUNVIS 846 ISO 46 (12 GAL)

OIL ANALYSIS REPORT

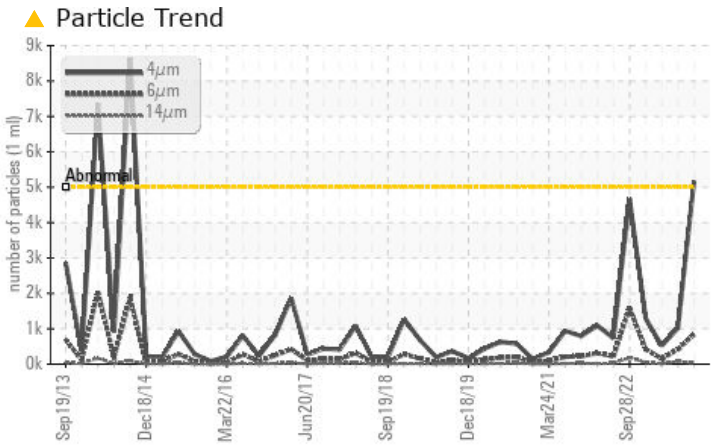
COMPONENT CONDITION SUMMARY

Sample Status				**ATTENTION**	NORMAL	NORMAL
Particles >4µm		ASTM D7647	>5000	▲ **5168**	1015	521
Oil Cleanliness		ISO 4406 (c)	>19/17/14	▲ **20/17/12**	17/16/14	16/14/11

Contamination
There is a light amount of silt (particulates < 14 microns in size) present in the oil.

We recommend you service the filters on this component. Resample at the next service interval to monitor.

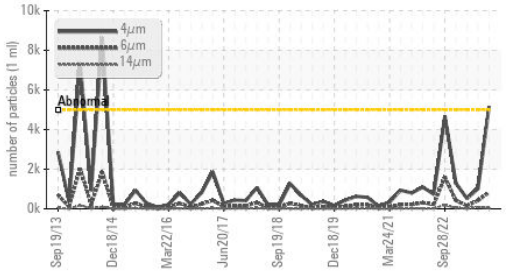
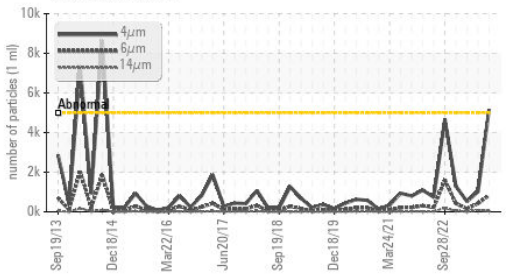
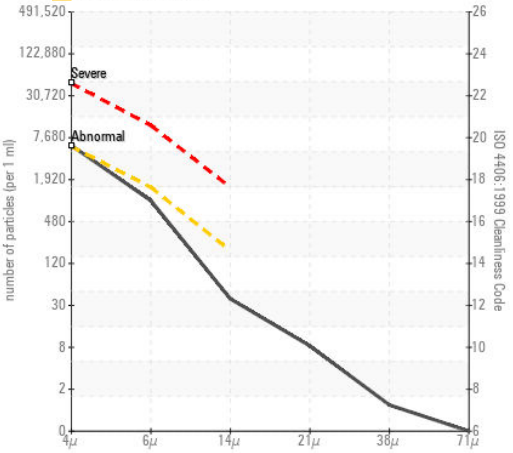
Particle Trend

FLUID CLEANLINESS		method	limit/base	current	history1	history2
Particles >4µm		ASTM D7647	>5000	▲ **5168**	1015	521
Particles >6µm		ASTM D7647	>1300	**839**	421	156
Particles >14µm		ASTM D7647	>160	**33**	81	12
Particles >21µm		ASTM D7647	>40	**7**	30	4
Particles >38µm		ASTM D7647	>10	**1**	1	0
Particles >71µm		ASTM D7647	>3	**0**	0	0
Oil Cleanliness		ISO 4406 (c)	>19/17/14	▲ **20/17/12**	17/16/14	16/14/11

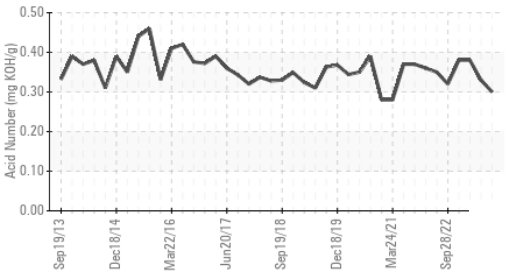
Fluid Condition
The AN level is acceptable for this fluid. The condition of the oil is suitable for further service.

FLUID DEGRADATION		method	limit/base	current	history1	history2
Acid Number (AN)	mg KOH/g	ASTM D974*		**0.30**	0.33	0.38

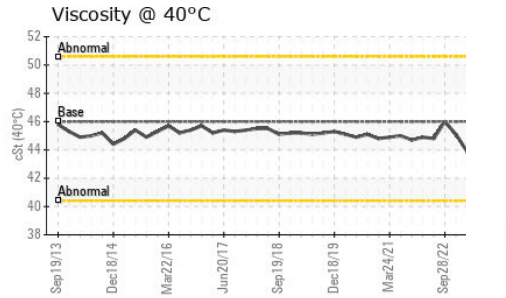
Viscosity @ 40°C

FLUID PROPERTIES		method	limit/base	current	history1	history2
Visc @ 40°C	cSt	ASTM D7279(m)	46.0	**44.6**	41.7	43.9
