PROBLEM SUMMARY

Area
4 Laminator
Machine Id
54-0105 Embosser
Component
Hydraulic System
Fluid
SUNOCO SUNVIS 846 ISO 46 (39 GAL)

OIL ANALYSIS REPORT

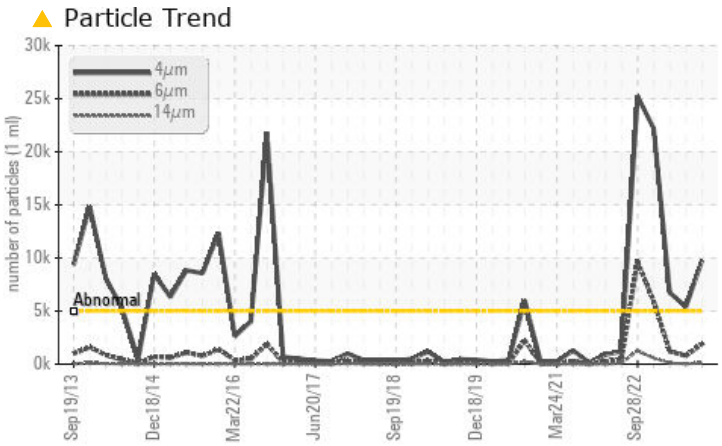
COMPONENT CONDITION SUMMARY

Sample Status				ATTENTION	ATTENTION	ATTENTION
Particles >4µm		ASTM D7647	>5000	▲ **9763**	▲ 5391	▲ 6733
Particles >6µm		ASTM D7647	>1300	▲ **1912**	786	1211
Oil Cleanliness		ISO 4406 (c)	>19/17/14	▲ **20/18/14**	▲ 20/17/12	▲ 20/17/14

Contamination
There is a light amount of silt (particulates < 14 microns in size) present in the oil.

We recommend you service the filters on this component. Resample at the next service interval to monitor.
