PROBLEM SUMMARY

Area
MTR [73954]
Machine Id
TINHGOV3
Component
Hydraulic System
Fluid
ESSO TERESSO ISO 32 (80 LTR)

OIL ANALYSIS REPORT

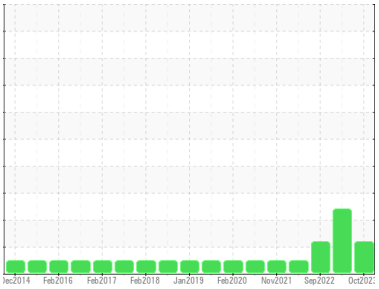
Sample Rating Trend

ISO

Sample Status				ABNORMAL	ABNORMAL	ABNORMAL
Particles >4µm		ASTM D7647	>5000	▲ **15331**	▲ 29365	▲ 23822
Particles >6µm		ASTM D7647	>1300	▲ **1812**	▲ 3429	▲ 2711
Oil Cleanliness		ISO 4406 (c)	>19/17/14	▲ **21/18/13**	▲ 22/19/13	▲ 22/19/13

We recommend you service the filters on this component. We recommend an early resample to monitor this condition.

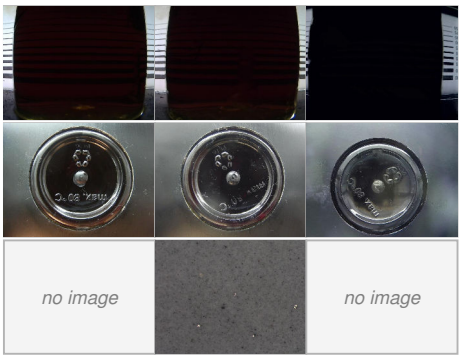
SAMPLE IMAGES	method	limit/base	current	history1	history2
Color					
Bottom					
PrtFilter

VISUAL		method	limit/base	current	history1	history2
White Metal	scalar	Visual*	NONE	**NONE**	▲ VLITE	NONE
Yellow Metal	scalar	Visual*	NONE	**NONE**	NONE	NONE
Precipitate	scalar	Visual*	NONE	**NONE**	NONE	NONE
Silt	scalar	Visual*	NONE	**NONE**	NONE	NONE
Debris	scalar	Visual*	NONE	**NONE**	NONE	NONE
Sand/Dirt	scalar	Visual*	NONE	**NONE**	NONE	NONE
Appearance	scalar	Visual*	NORML	**NORML**	NORML	NORML
Odor	scalar	Visual*	NORML	**NORML**	NORML	NORML
Emulsified Water	scalar	Visual*	>0.05	**NEG**	NEG	NEG
Free Water	scalar	Visual*		**NEG**	NEG	NEG
