Machine Id
MAIN ENGINE
Component
Port Main Engine
Fluid
SAE 15W40 (--- GAL)

Customer Id: CARIBOUIS
Sample No.: WC0754187
Lab Number: 02587725
Test Package: MAR 1

OIL ANALYSIS REPORT

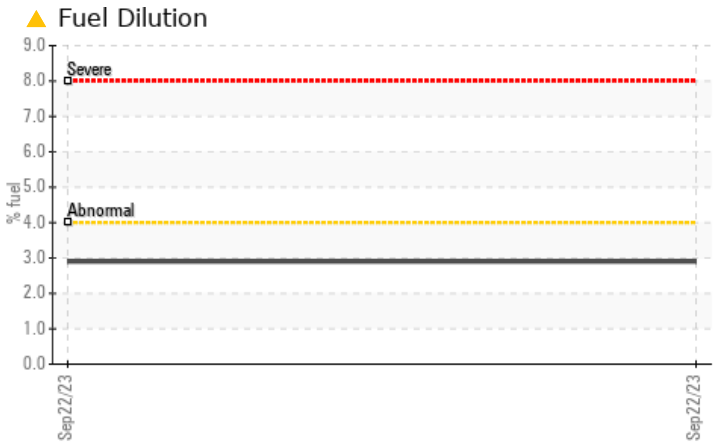
COMPONENT CONDITION SUMMARY

Sample Status				**MARGINAL**	---	---
Fuel	%	ASTM D7593*	>4.0	▲ **2.9**	---	---

Light fuel dilution occurring. No other contaminants were detected in the oil.

No corrective action is recommended at this time. Resample at the next service interval to monitor. Please specify the component make and model with your next sample. Please specify the brand, type, and viscosity of the oil on your next sample.

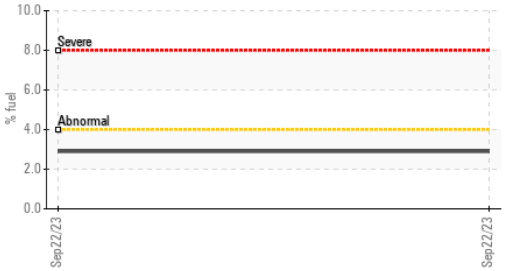
Fuel Dilution

CONTAMINANTS		method	limit/base	current	history1	history2
Silicon	ppm	ASTM D5185(m)	>20	**2**	---	---
Sodium	ppm	ASTM D5185(m)	>57	**2**	---	---
Potassium	ppm	ASTM D5185(m)	>20	**5**	---	---
Fuel	%	ASTM D7593*	>4.0	**2.9**	---	---

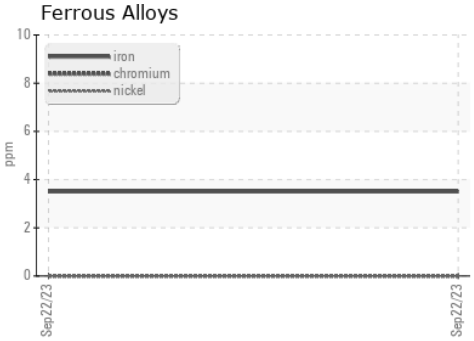
Ferrous Alloys

All component wear rates are normal.

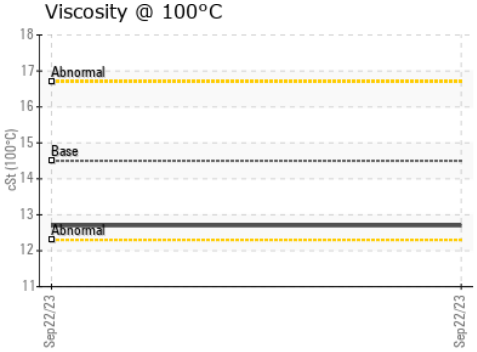
Viscosity @ 100°C

FLUID PROPERTIES		method	limit/base	current	history1	history2
Visc @ 100°C	cSt	ASTM D7279(m)	14.5	**12.7**	---	---
