PROBLEM SUMMARY

Area
Temboard/Service/Stock Preparation
Machine Id
N/A N/A [804-236-010] TB Softwood Refiner #1
Component
Hydraulic System
Fluid
SHELL TELLUS 68 (37 LTR)

OIL ANALYSIS REPORT

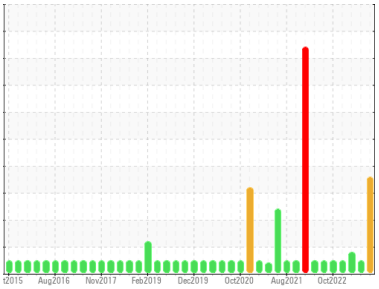
Sample Rating Trend

ISO

Sample Status				SEVERE	NORMAL	ATTENTION
Particles >6µm		ASTM D7647	>1300	**16274**	383	1602
Particles >14µm		ASTM D7647	>160	**467**	14	83
Particles >21µm		ASTM D7647	>40	**74**	6	27
Oil Cleanliness		ISO 4406 (c)	>--/17/14	**23/21/16**	19/16/11	21/18/14

Check seals and/or filters for points of contaminant entry. The air breather requires service. If unrated, we recommend that you replace with a suitable micron rated and/or desiccant air breather. If rated, we recommend that you service/replace the breather. We recommend you service the filters on this component. Resample in 30-45 days to monitor this situation.

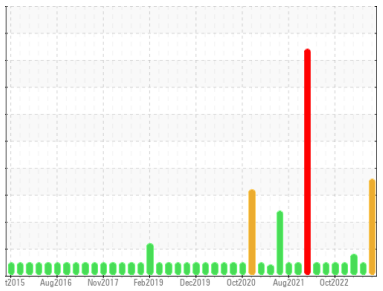
Sample Rating Trend

ISO

There is a high amount of silt (particulates < 14 microns in size) present in the oil. The water content is negligible. The system cleanliness code is much higher than the acceptable limit for the target ISO 4406 cleanliness code.

Check seals and/or filters for points of contaminant entry. The air breather requires service. If unrated, we recommend that you replace with a suitable micron rated and/or desiccant air breather. If rated, we recommend that you service/replace the breather. We recommend you service the filters on this component. Resample in 30-45 days to monitor this situation.

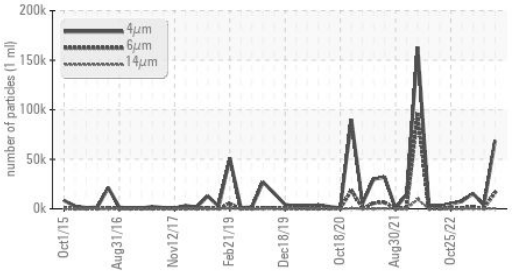
Particle Trend

FLUID CLEANLINESS		method	limit/base	current	history1	history2
Particles >4µm		ASTM D7647		**68781**	4094	15367
Particles >6µm		ASTM D7647	>1300	**16274**	383	1602
Particles >14µm		ASTM D7647	>160	**467**	14	83
Particles >21µm		ASTM D7647	>40	**74**	6	27
Particles >38µm		ASTM D7647	>10	**4**	1	0
Particles >71µm		ASTM D7647	>3	**0**	0	0
Oil Cleanliness		ISO 4406 (c)	>--/17/14	**23/21/16**	19/16/11	21/18/14
