Area
Metex - M00800
Machine Id
AM910
Component
Quench Oil
Fluid
NOT GIVEN (--- GAL)

Customer Id: CHECOB
Sample No.: E30000490
Lab Number: 02588618
Test Package: IND 2

OIL ANALYSIS REPORT

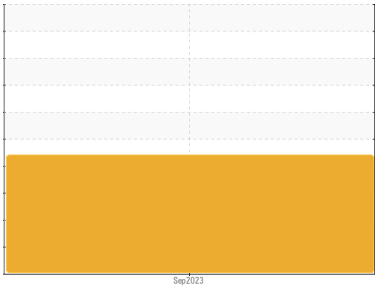
Sample Rating Trend

Sample Status				**ABNORMAL**	---	---
Iron	ppm	ASTM D5185(m)		▲ **20**	---	---
Water	%	ASTM D6304*		▲ **0.391**	---	---
ppm Water	ppm	ASTM D6304*		▲ **3917.5**	---	---
Particles >4µm		ASTM D7647	>5000	▲ **442059**	---	---
Particles >6µm		ASTM D7647	>1300	▲ **157459**	---	---
Particles >14µm		ASTM D7647	>160	▲ **834**	---	---
Particles >21µm		ASTM D7647	>40	▲ **112**	---	---
Oil Cleanliness		ISO 4406 (c)	>19/17/14	▲ **26/24/17**	---	---
Emulsified Water	scalar	Visual*		▲ **.5%**	---	---

This is a baseline read-out on the submitted sample.

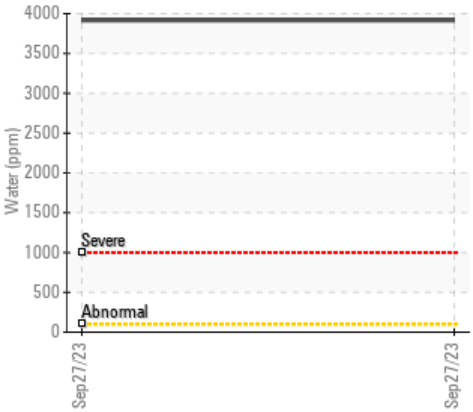
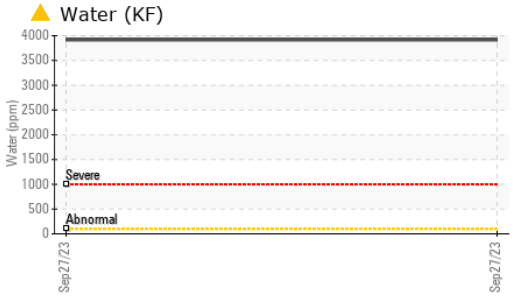
Contamination
ppm Water contamination levels are abnormally high. Water contamination levels are abnormally high. Particles >4µm are abnormally high. Particles >6µm are abnormally high. Oil Cleanliness are abnormally high. Particles >14µm are abnormally high. Particles >21µm are abnormally high.

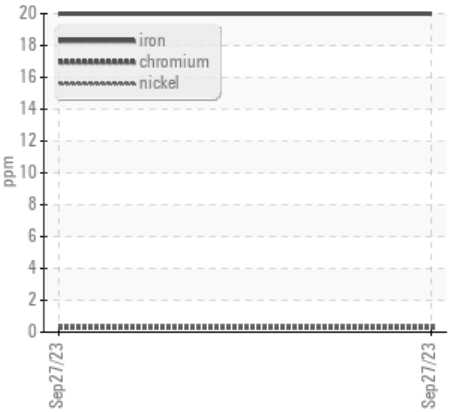
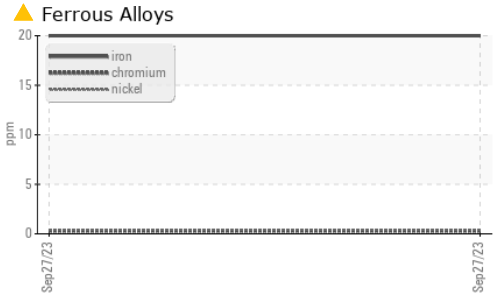
Wear
Iron ppm levels are noted.

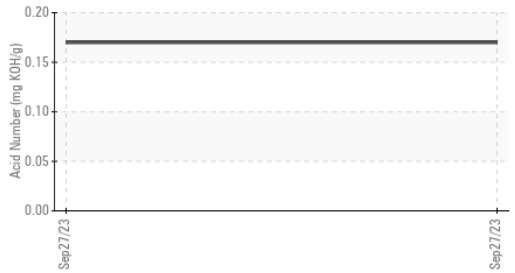
FLUID DEGRADATION		method	limit/base	current	history1	history2
Acid Number (AN)	mg KOH/g	ASTM D974*		**0.17**	---	---
