Area
[100000067911]
Machine Id
HPU G002
Component
Hydraulic System
Fluid
ESSO NUTO H ISO 32 (--- GAL)

Customer Id: ALGMIS
Sample No.: WC0779186
Lab Number: 02589610
Test Package: IND 2

OIL ANALYSIS REPORT

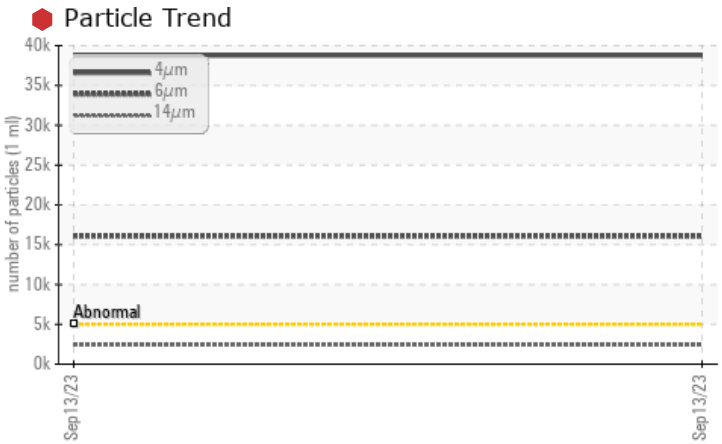
COMPONENT CONDITION SUMMARY

Sample Status				SEVERE	---	---
Particles >4µm		ASTM D7647	>5000	▲ 38768	---	---
Particles >6µm		ASTM D7647	>1300	⬢ 16072	---	---
Particles >14µm		ASTM D7647	>160	⬢ 2406	---	---
Particles >21µm		ASTM D7647	>40	⬢ 637	---	---
Particles >38µm		ASTM D7647	>10	▲ 21	---	---
Oil Cleanliness		ISO 4406 (c)	>19/17/14	⬢ 22/21/18	---	---

There is a high amount of particulates (2 to 100 microns in size) present in the oil.

We advise that you check all areas where contaminants can enter the system. We advise that you perform a filter service, and use off-line filtration to improve the cleanliness of the system fluid. The air breather requires service. If unrated, we recommend that you replace with a suitable micron rated and/or desiccant air breather. If rated, we recommend that you service/replace the breather. Resample in 30-45 days to monitor this situation. NOTE: Please provide information regarding reservoir capacity, filter type and micron rating with next sample.

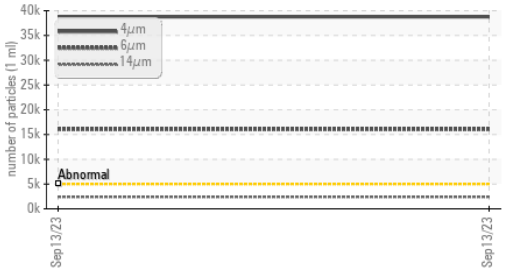
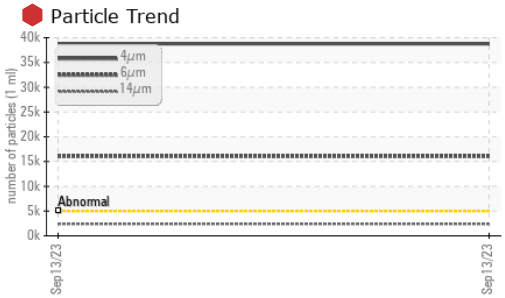
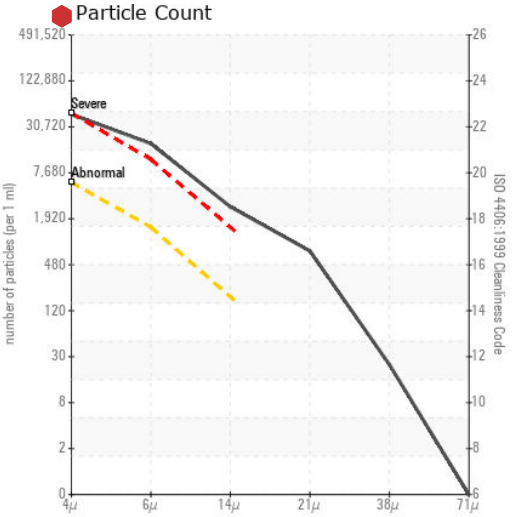
Particle Trend

FLUID CLEANLINESS		method	limit/base	current	history1	history2
Particles >4µm		ASTM D7647	>5000	▲ **38768**	---	---
Particles >6µm		ASTM D7647	>1300	● **16072**	---	---
Particles >14µm		ASTM D7647	>160	● **2406**	---	---
Particles >21µm		ASTM D7647	>40	● **637**	---	---
Particles >38µm		ASTM D7647	>10	▲ **21**	---	---
Particles >71µm		ASTM D7647	>3	**0**	---	---
Oil Cleanliness		ISO 4406 (c)	>19/17/14	● **22/21/18**	---	---

We advise that you check all areas where contaminants can enter the system. We advise that you perform a filter service, and use off-line filtration to improve the cleanliness of the system fluid. The air breather requires service. If unrated, we recommend that you replace with a suitable micron rated and/or desiccant air breather. If rated, we recommend that you service/replace the breather. Resample in 30-45 days to monitor this situation. NOTE: Please provide information regarding reservoir capacity, filter type and micron rating with next sample.
