Area
PLANT 1
Machine Id
BAY 4 SLT
Component
1 Hydraulic System
Fluid
COMMERCIAL OIL LUBRIKO AW 46 (100 LTR)

Customer Id: TAYSTO
Sample No.: WC0754644
Lab Number: 02590014
Test Package: IND 2

OIL ANALYSIS REPORT

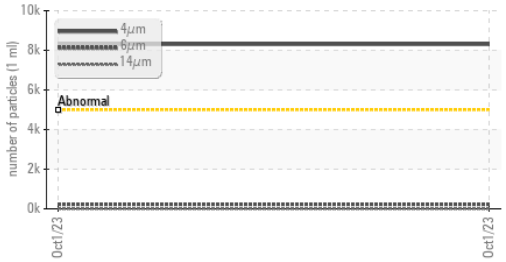
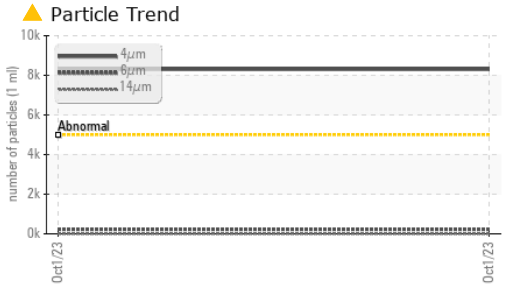
Particle Trend

Sample Status				ATTENTION	---	---
Particles >4µm		ASTM D7647	>5000	▲ 8306	---	---
Oil Cleanliness		ISO 4406 (c)	>19/17/14	▲ 20/15/10	---	---

We recommend you service the filters on this component. Resample at the next service interval to monitor. Please specify the component make and model with your next sample.

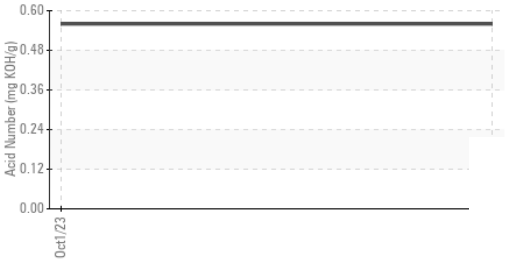
Acid Number

Fluid Condition
The AN level is acceptable for this fluid. The condition of the oil is suitable for further service.

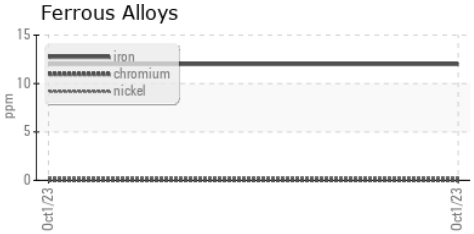
Ferrous Alloys

Wear
All component wear rates are normal.

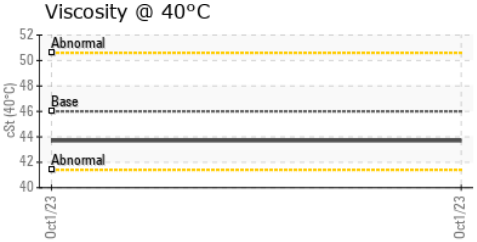
Viscosity @ 40°C

FLUID PROPERTIES		method	limit/base	current	history1	history2
Visc @ 40°C	cSt	ASTM D7279(m)	46	**43.7**	---	---

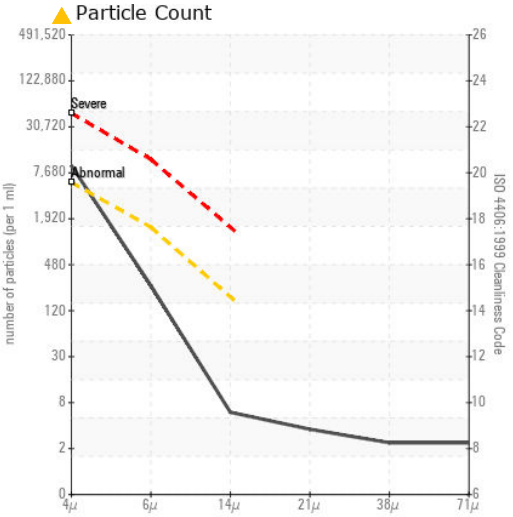
Particle Count

Contamination
There is a light amount of silt (particulates < 14 microns in size) present in the oil.

FLUID CLEANLINESS		method	limit/base	current	history1	history2
Particles >4µm		ASTM D7647	>5000	▲ **8306**	---	---
Particles >6µm		ASTM D7647	>1300	**225**	---	---
Particles >14µm		ASTM D7647	>160	**5**	---	---
Particles >21µm		ASTM D7647	>40	**3**	---	---
Particles >38µm		ASTM D7647	>10	**2**	---	---
Particles >71µm		ASTM D7647	>3	**2**	---	---
Oil Cleanliness		ISO 4406 (c)	>19/17/14	▲ **20/15/10**	---	---

Recommendation
We recommend you service the filters on this component. Resample at the next service interval to monitor. Please specify the component make and model with your next sample.
