Customer Id: TAYSTO
Sample No.: WC0754613
Lab Number: 02590018
Test Package: IND 2

OIL ANALYSIS REPORT

Area
PLANT 5
Machine Id
BAY 15 PACKAGING LINE
Component
1 Hydraulic System
Fluid
COMMERCIAL OIL LUBRIKO AW 46 (500 LTR)

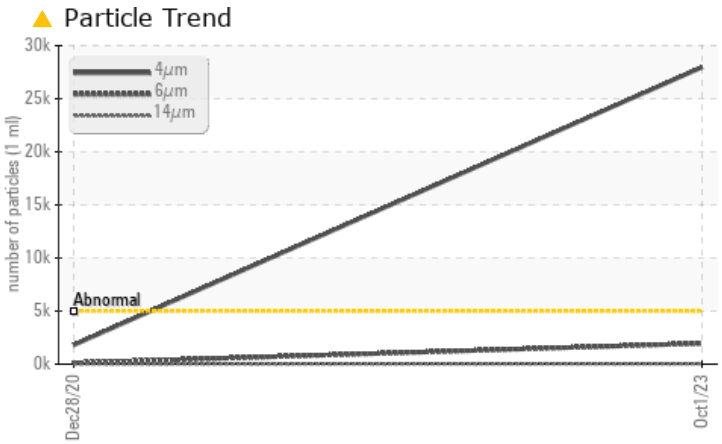
COMPONENT CONDITION SUMMARY

Sample Status				**ABNORMAL**	NORMAL	---
Particles >4µm		ASTM D7647	>5000	▲ **27972**	1800	---
Particles >6µm		ASTM D7647	>1300	▲ **1952**	113	---
Oil Cleanliness		ISO 4406 (c)	>19/17/14	▲ **22/18/12**	18/14/10	---
White Metal	scalar	Visual*	NONE	▲ **LIGHT**	NONE	---
Debris	scalar	Visual*	NONE	▲ **LIGHT**	NONE	---
PrtFilter

We advise that you check all areas where contaminants can enter the system. We advise that you check for visible metal particles in the oil. We recommend you service the filters on this component. We recommend an early resample to monitor this condition. Please specify the component make and model with your next sample. We suspect that the abnormal contaminant(s) is the result of incorrect sampling technique. DISCLAIMER: Interpretation of results is based on the sample as received from the customer. The condition of the sample and the method of sampling cannot be verified.

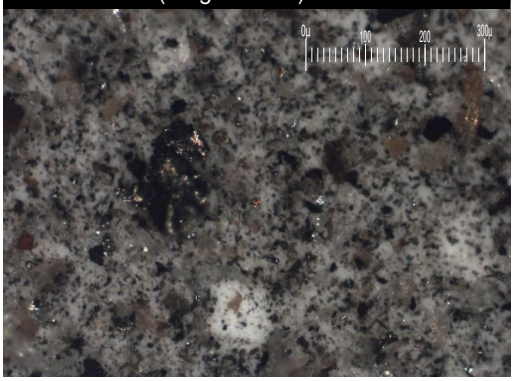
Particle Filter (Magn: 100 x)

Light concentration of visible metal present.

There is a moderate amount of silt (particulates < 14 microns in size) present in the oil. Light concentration of visible dirt/debris present in the oil.

We advise that you check all areas where contaminants can enter the system. We advise that you check for visible metal particles in the oil. We recommend you service the filters on this component. We recommend an early resample to monitor this condition. Please specify the component make and model with your next sample. We suspect that the abnormal contaminant(s) is the result of incorrect sampling technique.
DISCLAIMER: Interpretation of results is based on the sample as received from the customer. The condition of the sample and the method of sampling cannot be verified.

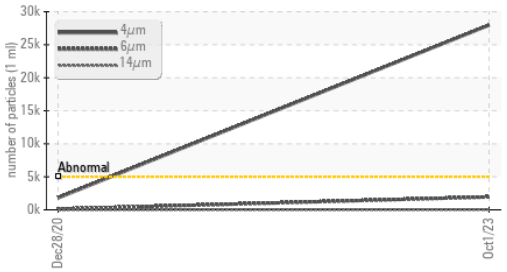
Particle Trend

FLUID CLEANLINESS		method	limit/base	current	history1	history2
Particles >4µm		ASTM D7647	>5000	▲ **27972**	1800	---
Particles >6µm		ASTM D7647	>1300	▲ **1952**	113	---
Particles >14µm		ASTM D7647	>160	**22**	10	---
Particles >21µm		ASTM D7647	>40	**9**	4	---
Particles >38µm		ASTM D7647	>10	**1**	0	---
Particles >71µm		ASTM D7647	>3	**0**	0	---
Oil Cleanliness		ISO 4406 (c)	>19/17/14	▲ **22/18/12**	18/14/10	---

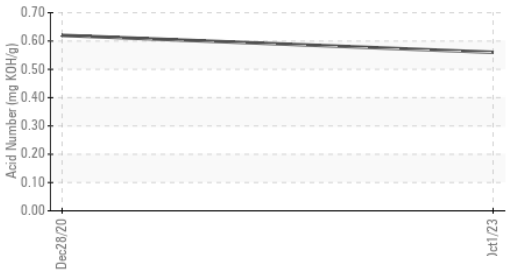
The AN level is acceptable for this fluid. The oil is still serviceable provided that the contaminant(s) can be reduced to acceptable levels.

FLUID DEGRADATION		method	limit/base	current	history1	history2
Acid Number (AN)	mg KOH/g	ASTM D974*		**0.56**	0.62	---

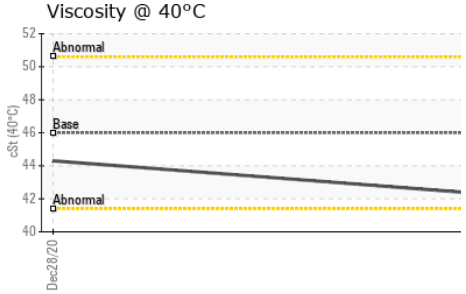
Viscosity @ 40°C

FLUID PROPERTIES		method	limit/base	current	history1	history2
Visc @ 40°C	cSt	ASTM D7279(m)	46	**42.3**	44.3	---
