PROBLEM SUMMARY

Area
5
Machine Id
5-3-230-D Pump Station for Atox Roller Lube
Component
Reservoir Bearing Lube
Fluid
MOBIL SHC 639 (1000 LTR)

OIL ANALYSIS REPORT

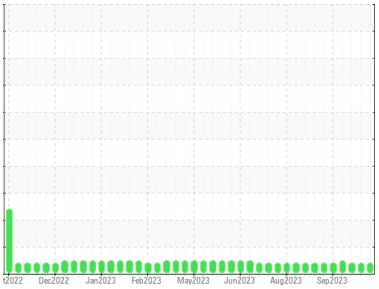
Sample Rating Trend

VISCOSITY

Sample Status				**ABNORMAL**	ABNORMAL	ABNORMAL
Visc @ 40°C	cSt	ASTM D7279(m)	923	▲ **697**	▲ 696	▲ 680

Resample at the next service interval to monitor.

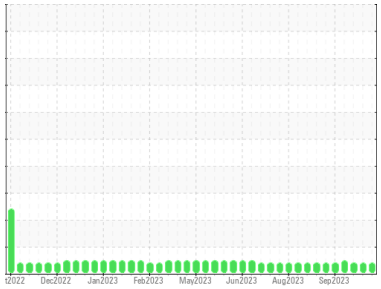
Sample Rating Trend

VISCOSITY

Fluid Condition
Viscosity of sample indicates oil is within ISO 680 range, advise investigate. The AN level is acceptable for this fluid. The condition of the oil is suitable for further service.

Recommendation
Resample at the next service interval to monitor.

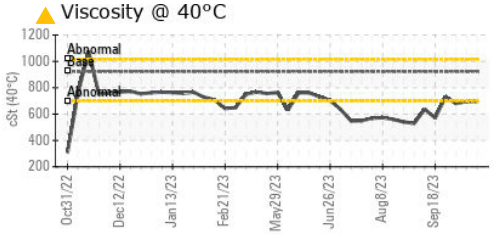
▲ Viscosity @ 40°C

FLUID PROPERTIES		method	limit/base	current	history1	history2
Visc @ 40°C	cSt	ASTM D7279(m)	923	▲ **697**	▲ 696	▲ 680
