Area
Saugeen Shores SP-17701
Machine ID
ECW #1
Component
Hydraulic System
Fluid
MOBIL AERO HF (280 LTR)

Customer Id: VESTAS
Sample No.: WC0835229
Lab Number: 02590625
Test Package: IND 2

OIL ANALYSIS REPORT

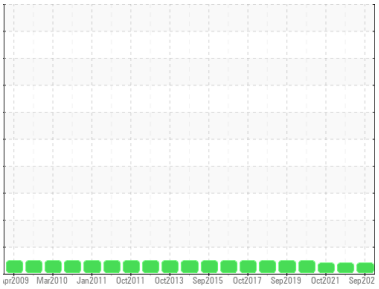
Sample Rating Trend

VISCOSITY

Sample Status				**ABNORMAL**	ABNORMAL	ABNORMAL
Visc @ 40°C	cSt	ASTM D7279(m)	14.0	▲ **11.5**	▲ 11.5	▲ 11.6

Resample at the next service interval to monitor.

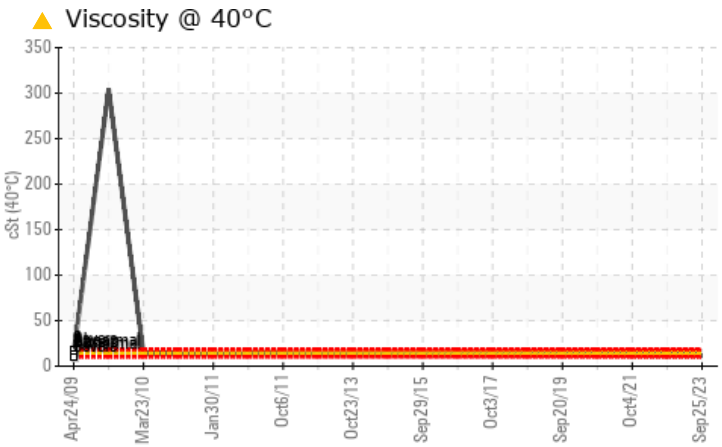
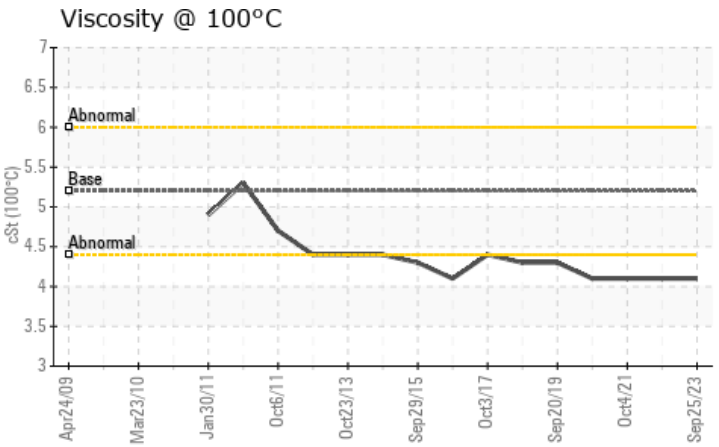
COMPONENT CONDITION SUMMARY

Fluid Condition
Viscosity of sample indicates oil is within ISO 10 range, advise investigate. The AN level is acceptable for this fluid. The condition of the oil is suitable for further service.

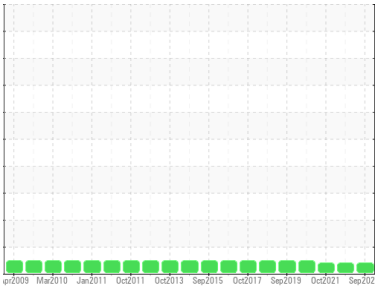
Sample Rating Trend

VISCOSITY

Recommendation
Resample at the next service interval to monitor.
