Area
Toyota - 888058
Machine Id
A2310106
Component
Unknown Component
Fluid
NOT GIVEN (--- GAL)

Customer Id: CHECOB
Sample No.: E30000551
Lab Number: 02590631
Test Package: IND 2

OIL ANALYSIS REPORT

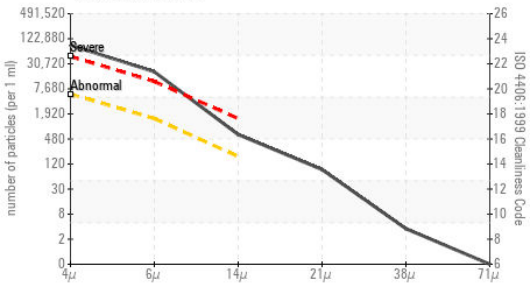
Particle Count

Contamination
ppm Water contamination levels are severely high. Water contamination levels are severely high. Water contamination levels are severely high.. Particles >4µm are abnormally high. Particles >6µm are abnormally high. Oil Cleanliness are abnormally high. Particles >14µm are abnormally high. Particles >21µm are notably high.

FLUID CLEANLINESS		method	limit/base	current	history1	history2
Particles >4µm		ASTM D7647	>5000	▲ **74589**	---	---
Particles >6µm		ASTM D7647	>1300	▲ **17156**	---	---
Particles >14µm		ASTM D7647	>160	▲ **539**	---	---
Particles >21µm		ASTM D7647	>40	▲ **78**	---	---
Particles >38µm		ASTM D7647	>10	**3**	---	---
Particles >71µm		ASTM D7647	>3	**0**	---	---
Oil Cleanliness		ISO 4406 (c)	>19/17/14	▲ **23/21/16**	---	---

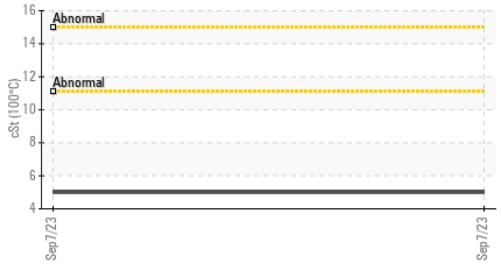
Viscosity @ 100°C

Fluid Condition
Visc @ 100°C is abnormally low. Visc @ 40°C is abnormally low.

FLUID PROPERTIES		method	limit/base	current	history1	history2
Visc @ 40°C	cSt	ASTM D7279(m)		▲ **46.6**	---	---
Visc @ 100°C	cSt	ASTM D7279(m)		▲ **5**	---	---
